TREE INVENTORY

Prepared for
FRIENDS OF ROCKHAVEN FOUNDATION

Prepared by
JAMES KOMEN – CLASS ONE ARBORICULTURE INC.
RCA #555, BCMA #WE-9909B
(818)495-5344
CLASSONEARBORICULTURE@GMAIL.COM
MAY 24, 2015

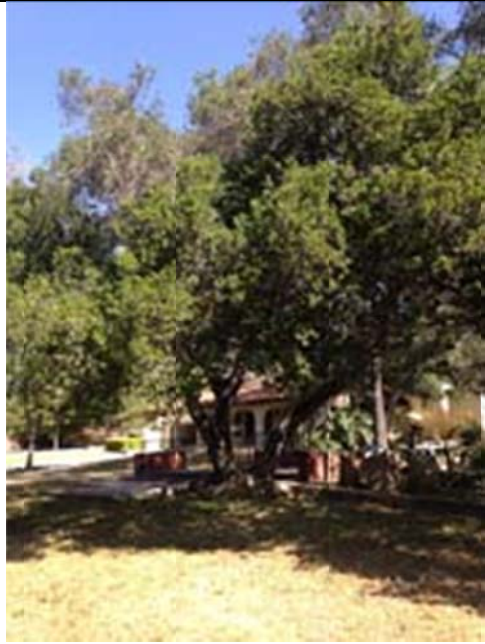
<p>Tree #1 <i>Fraxinus uhdei</i> – Shamel Ash</p> <p>There is a significant load of deadwood in the canopy of this tree that should be pruned out in the early fall to mitigate the hazard of branch failure onto pedestrians or vehicles below. The tree has good structure. Since there are no height limitations on the site, the tree can be allowed to grow as tall as its natural form allows.</p> <p>The tree is located very close to the main entrance driveway. The roots are already beginning to damage the asphalt. They are also pushing out against the concrete along the side of the road. As much as possible, the roots should be preserved when repairing the driveway. Severing roots this close to the trunk could be detrimental to the health and safety of the tree. The best option for the health of the tree is to spot-repair the road where it has lifted rather than resurfacing it entirely.</p>
 	<p>Tree #2 <i>Hymenosporum flavum</i> – Sweetshade</p> <p>This tree appears to have had many of its low and interior shoots pruned out in the past. Very little should be pruned from this tree at this time, and it should be allowed to regain canopy mass.</p>

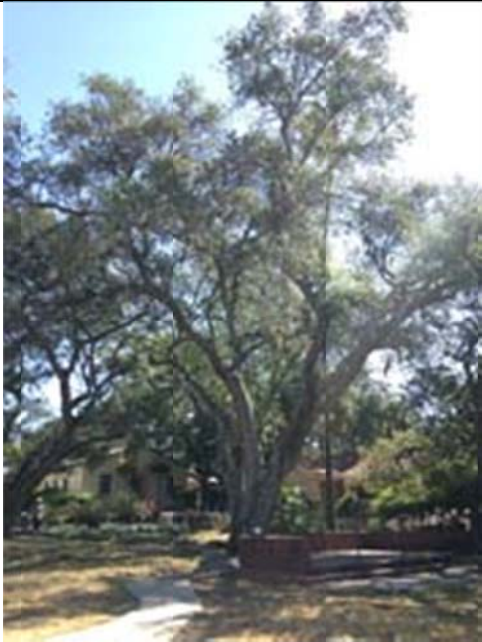
Tree #6

This dominant mature oak is a prime landscape asset. Unfortunately, its size has grown into conflict with the existing patio. In this case, I recommend preserving the tree and repairing the patio around it.

Some of the concrete comprising the planter space has become embedded in the bark. When the patio is renovated, this concrete should remain and not be removed. Removing it would further damage the tree. Rather, building materials not in direct contact with the tree should be removed within at least a 3 foot radius around the trunk, except for the concrete that has already become impounded in the bark.

There is evidence of an old fungal fruiting body at the base of the tree on the western side. This indicates that there has been some sort of root injury during previous care for this patio. This root injury appears to be relatively old. The tree should periodically be monitored for other fungal fruiting bodies. They usually appear during the rainy season. If the decayed wood becomes more apparent on the root crown, it may be indicative of a structural deficiency. The tree should be reevaluated for hazard at that time. For now, it should just be monitored.

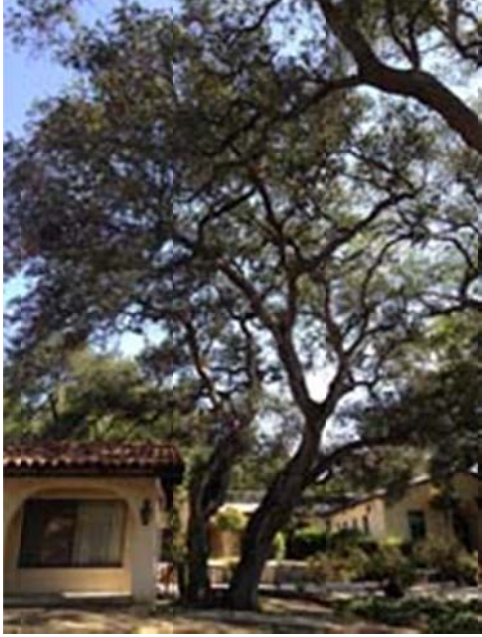
<p>Tree #7 <i>Quercus agrifolia</i> – Coast Live Oak</p> <p>The canopy of this historic oak tree is beginning to look a little sparser than ideal. It may be that an accumulation of root defects has reduced this tree's access to water. Growth has slowed but not stopped.</p> <p>As a result of the decline in foliage density, the bark has received greater sun exposure. In response, the tree has begun to grow watersprouts along the trunk. These shoots should be retained because their leaves will shade the bark and protect it from sunburn which could further stress the tree.</p> <p>There is evidence of woodpecker damage in the middle trunk of the tree about 20 feet above the ground. Nothing can be done to repair these wounds, but they should be monitored for onset of decay. If decay enters the tree through these woodpecker holes, girdles the tree, and shuts off the water supply to the foliage, then the entire trunk may be lost.</p> <p>There is a buildup of deadwood in the canopy, and there are several dead fronds from the adjacent palm tree hanging in the upper canopy. They should be removed for safety.</p>

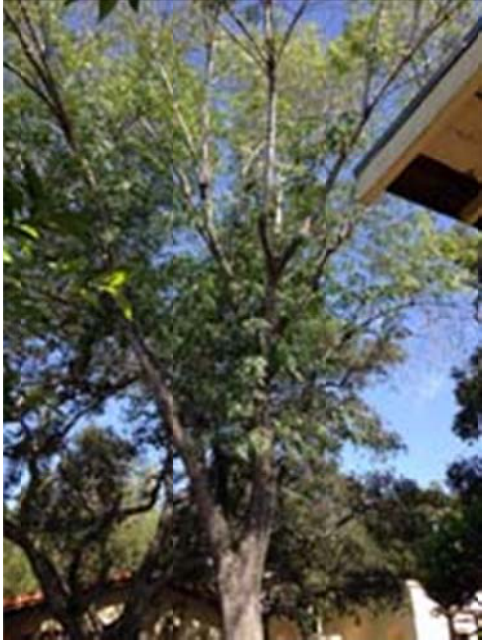
<p>Tree #8 <i>Quercus agrifolia</i> – Coast Live Oak</p> <p>Like its neighbor, this tree's canopy is not as dense as a healthy tree's canopy would be. It is possible that it has accumulated root injuries that reduced the water supply to the upper canopy.</p> <p>There is a buildup of deadwood in the canopy that should be removed, especially the dead branches over the adjacent building.</p> <p>I observed several scattered weeping sites on the trunk about 4 feet off the ground. These could be early signs of a borer invasion or a Phytophthora infection. Further analysis will be needed to determine the cause of these exudation sites.</p>

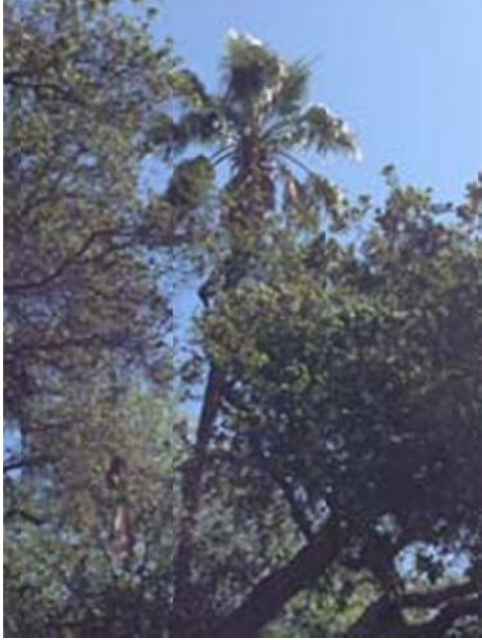
Tree #9

After a program of restoration pruning, the tree will be able to better cope with the force of the wind. This tree has already begun to displace the patio around it with its root system. A decision should be made whether to preserve the patio or the tree. My recommendation is to preserve the tree and make occasional fixes to the displaced patio masonry.

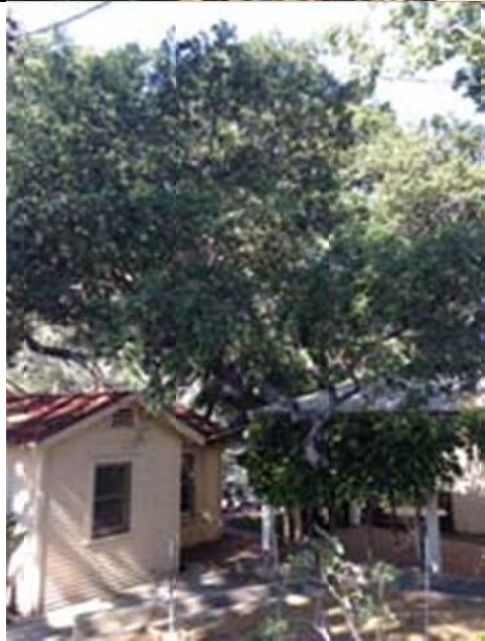
Tree #27

There is a safety line installed in the canopy two thirds of the way up the trunks. This is an excellent safety precaution, and it was correctly installed using the through-bolt method. The safety line should be inspected annually by a climber for stability. Additionally, a climber should inspect the decaying wound sites on the main trunk.

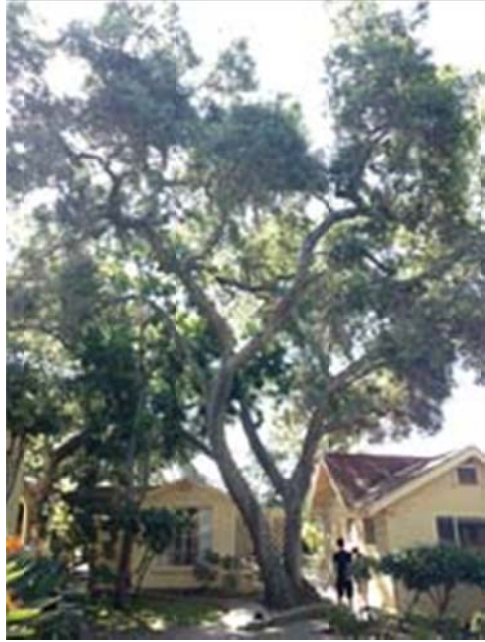
Tree #28

All of the foliage appears healthy and vigorous. A careful balance should be maintained between roof clearance for fire safety and preserving the low fringe for architectural aesthetics. I observed no trunk defects, fungal infections, or insect infestations.

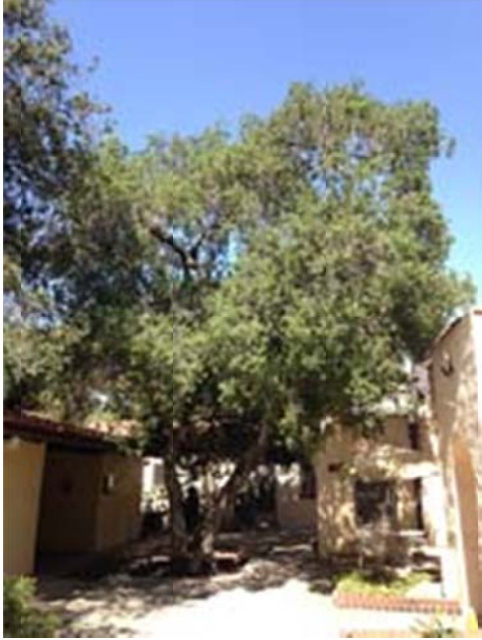
Tree #29 is another oak that is growing very close to the buildings. It was once cabled in the past, but the lag-screw fixtures have since pulled out of the trunk, and the old cable has been left hanging in the canopy. A safety line should be reinstalled in the tree to mitigate the potential hazard of a trunk failing onto a building.

In the past, the tree was cabled using the lag bolt method. Since that cable installation, one of the cables has broken and remains hanging in the canopy. The other cable appears sturdy, but it was incorrectly installed. At some point in the future, it may be advisable to replace the old cable system using the correct through-bolt method. The old cable should not be removed until a new cable system is in place. Furthermore, the lag bolts that have been swallowed up by the tree's callouses should not be removed. Rather, if the existing cables are removed, they should be cut flush to the outer bark of the tree without damaging the bark.

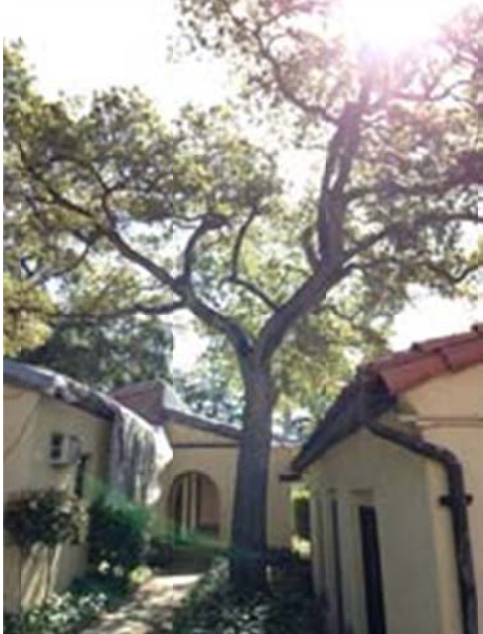
Tree #30

The most important hazard tree identified in this report is Tree #30. There is a large cavity at the base of the tree that is a severe structural deficiency. The tree is located in a courtyard between two buildings, and both of its very large trunks overhang the buildings. I recommend considering this tree for removal to mitigate the hazard. If removal is not a politically acceptable option, then the tree could be cabled to reduce the likelihood of a trunk tearing out. The cabling would have to be accompanied by a disclaimer that it may end up being ineffective, and damage to an adjacent building could still result. Regardless of what is done, this tree should be discussed and addressed by the landscape managers immediately.

If the tree is retained in the landscape, I highly recommend installing a cable approximately two thirds up the height of the tree to support the weight of the weakened trunk. However, my recommendation is to remove and replace this hazardous tree.

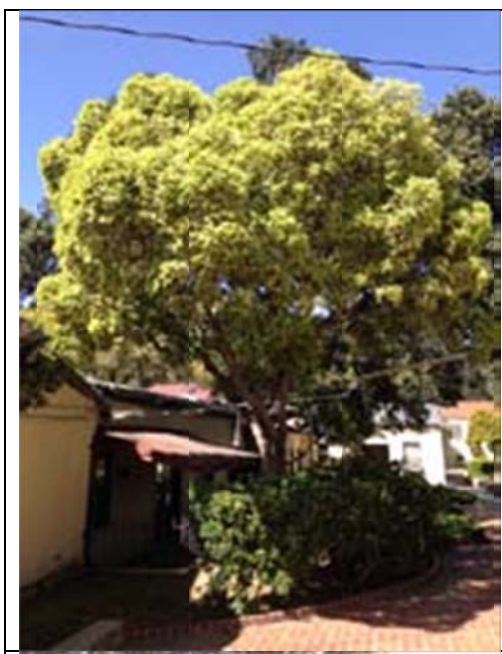
<p>Tree #33 <i>Quercus agrifolia</i> – Coast Live Oak</p> <p>This Coast Live Oak has limited root space between the building and the raised planter to the north. The roots are beginning to crack the patio. In the near future, the eastern trunk will also press up against the awning. Care should be taken to avoid damaging the trunk or the roots when repairing the infrastructure.</p> <p>There is a small load of deadwood in the canopy. This deadwood should be removed before it falls on the roof. The tree should also be pruned at least 5 feet away from the roof per City of Glendale fire code regulations.</p>

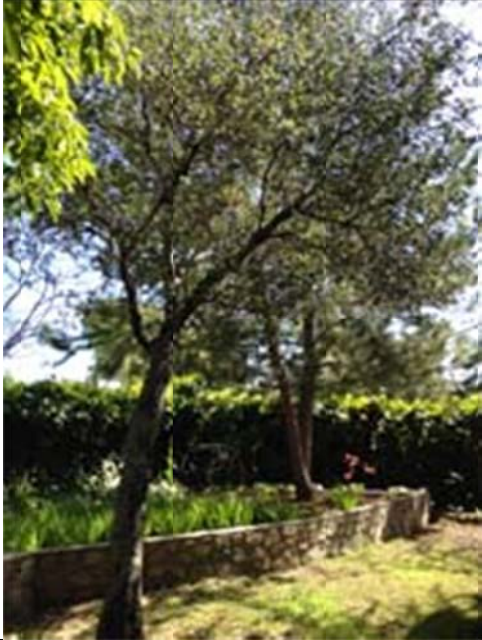
<p>Tree #36.1 <i>Quercus agrifolia</i> – Coast Live Oak</p> <p>This is a healthy oak tree growing in a grove with a canary palm and another oak. This tree should be preserved where possible. However, the low branches that are touching the roof should be pruned back to a height of 5 feet per City of Glendale fire regulations. Eventually, this tree will cause the patio area to crack and uplift. When the patio is repaired, care should be taken to avoid cutting roots.</p>

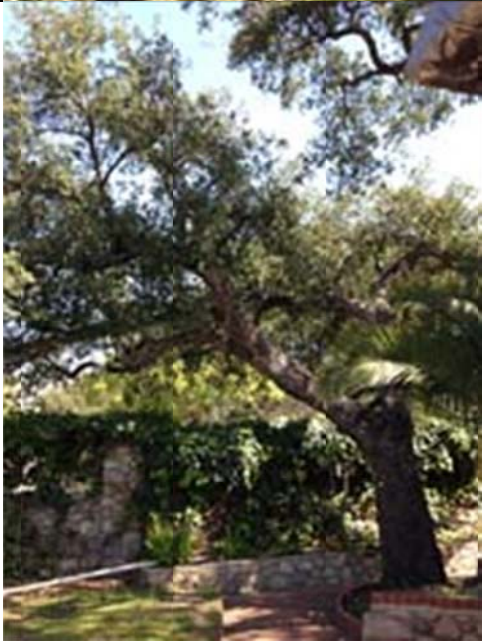
Tree #36.2

This young Coast Live Oak will be a good succession tree for this corner of the property. In the short-term, some fill soil should be applied around the root system to cover up the surface roots and protect them from damage.

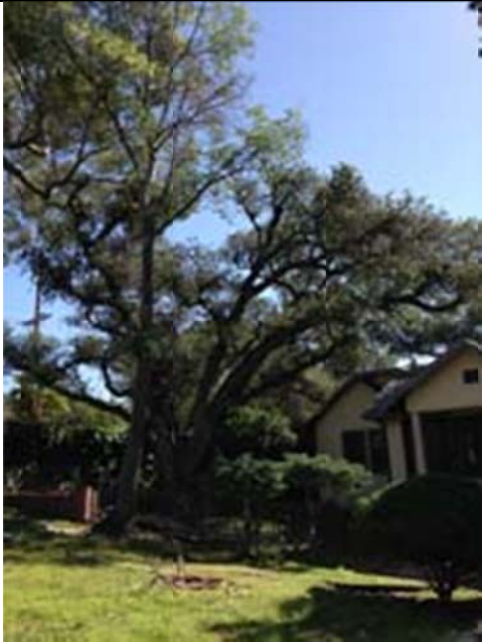
Tree #38

This oak tree is growing nicely in the grove. Its prevailing lean to the north over Hermosa Avenue is not a reason for concern. The tree is stable in the ground, and the species is known to grow outward and downward in its natural form without failing at the trunk or root crown. It should be pruned regularly for sidewalk and street clearance.

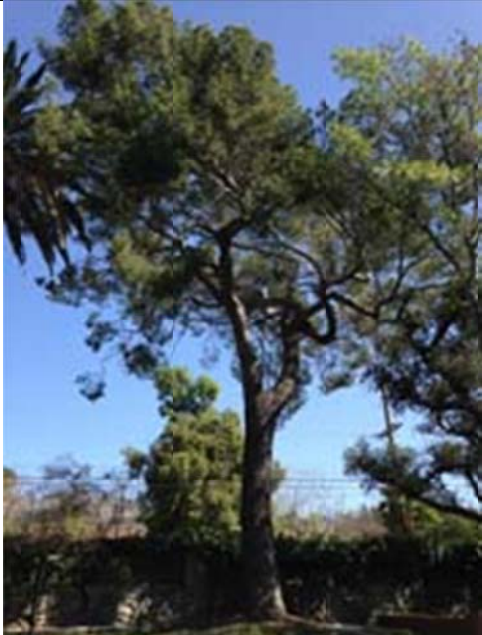
<p>Tree #39 <i>Quercus agrifolia</i> – Coast Live Oak</p> <p>This is one of the largest specimens of Coast Live Oak on the property. This multi trunk tree is doing an excellent job of shading the courtyard around it. In the past, it looks as though there was some aggressive pruning or some unprecedented dieback that resulted in large limb loss. As a result, the tree has grown new watersprouts along its affected limbs.</p> <p>There are no visible active bark expansion cracks on the trunks. This indicates that the tree is in stable or declining health. Currently, the deadwood is small enough to remain. If larger deadwood appears, it should be pruned out for safety. This tree should be maintained for roof clearance. No limbs should be allowed to grow within 5 feet of the roof according to fire code.</p> <p>I recommend having a climbing arborist give this tree an aerial inspection to look for defects that may not have been apparent from the ground.</p>

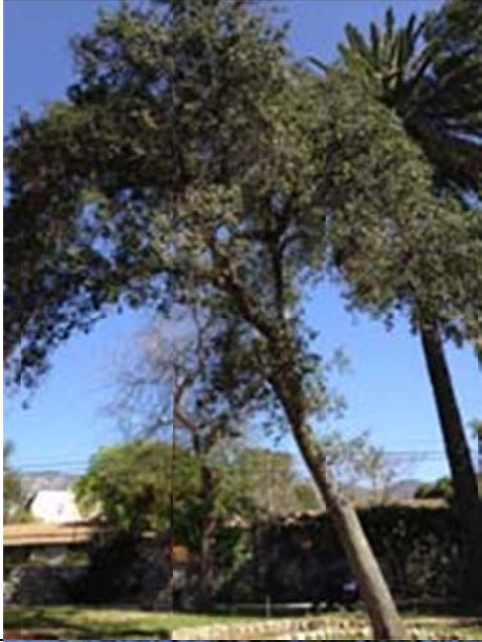
<p>Tree #40 <i>Pinus halepensis</i> – Aleppo Pine</p> <p>This old pine tree has good structure and appears to be in good health. It is relatively clean of deadwood, but there are a few smaller dead branches that can be removed before they self-prune. Care should be taken to give this tree an aerial inspection every few years to look for defects in the limbs that overhang the street.</p>

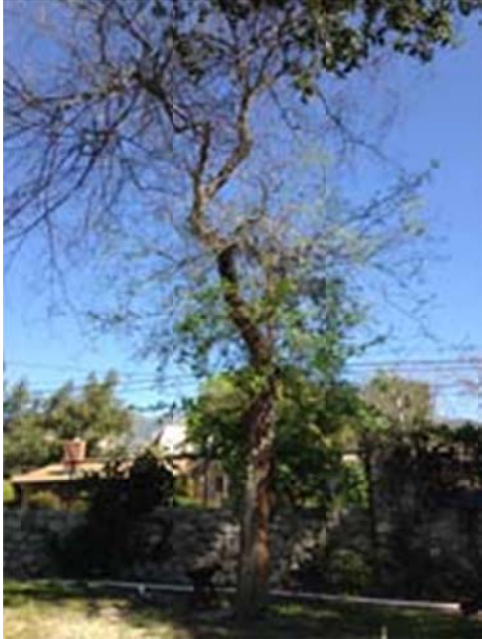
Tree #46

At the base of the tree on the northern side, there is a large root injury. It is likely that the tree was stressed due to this root injury some years ago. The tree should be maintained for clearance, and deadwood should be removed regularly, but no action needs to be taken at this time.

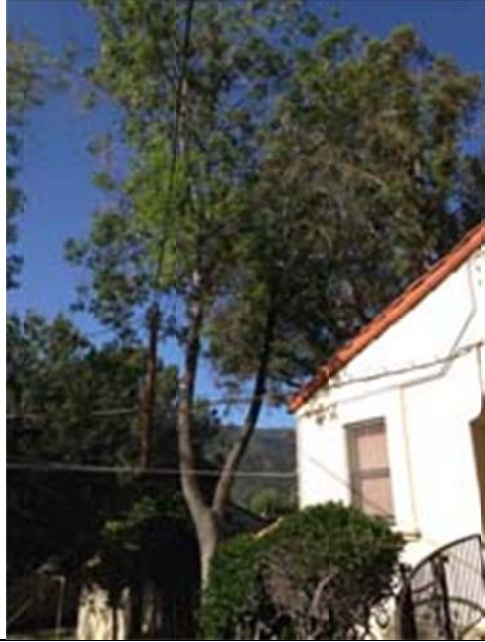
Tree #53

This tree was planted too close to the building, and it will inevitably cause damage to the surrounding hardscape. A decision should be made whether the tree will be preserved and the hardscape regularly repaired or the tree will be removed in favor of preserving the infrastructure. In the short-term, clearance should be pruned for the power lines running through the canopy.

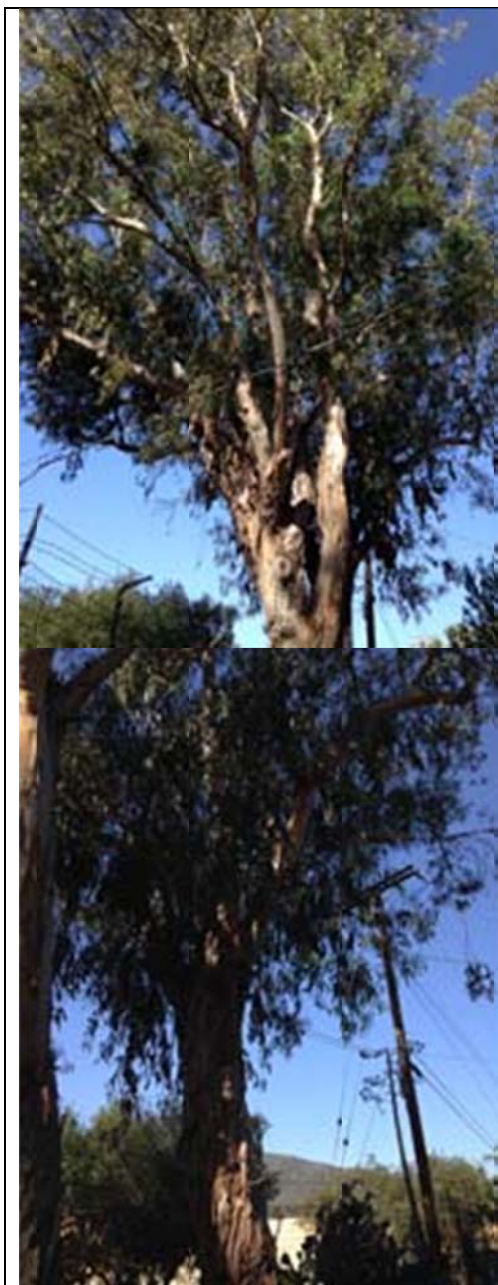
Trees #54-55

These trees also have power lines running through them and will need to be maintained for line clearance every two to five years. They should not be topped or headed back. Response growth to topping cuts is always weakly attached to the parent stem and is more susceptible to tear out.

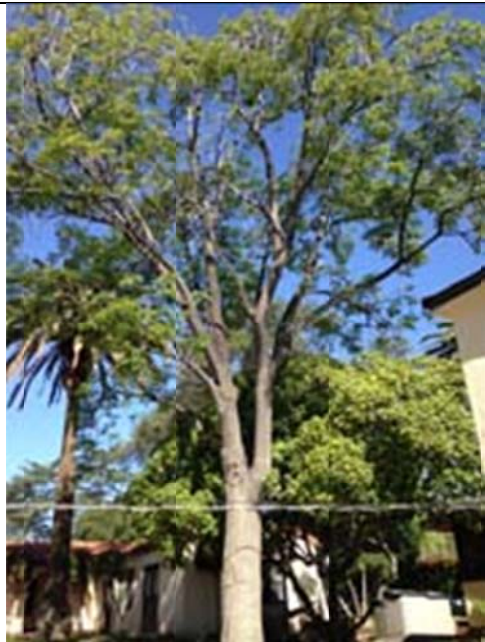
Tree #57

In the short-term, the deadwood should be removed from the tree before it self-prunes.

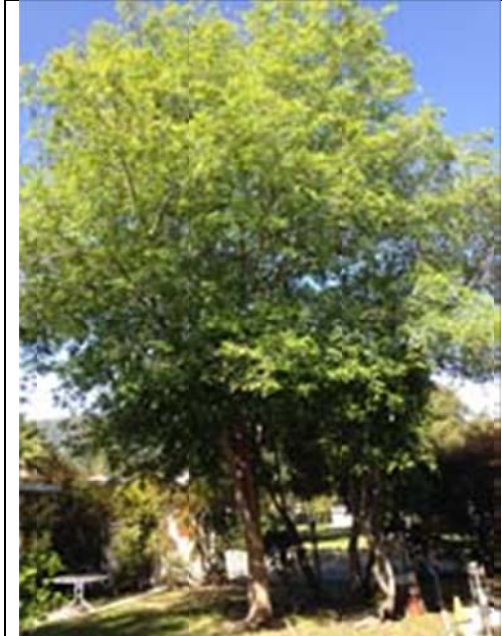
<p>Tree #61.1 <i>Quercus agrifolia</i> – Coast Live Oak</p> <p>This Coast Live Oak volunteer is a healthy specimen on site. However, it is growing very close to the back wall, and the back wall may eventually crack due to the growth of this tree. Preservation of this tree will require the eventual repair of the adjacent wall. It will need to be pruned every few years for sidewalk clearance.</p>

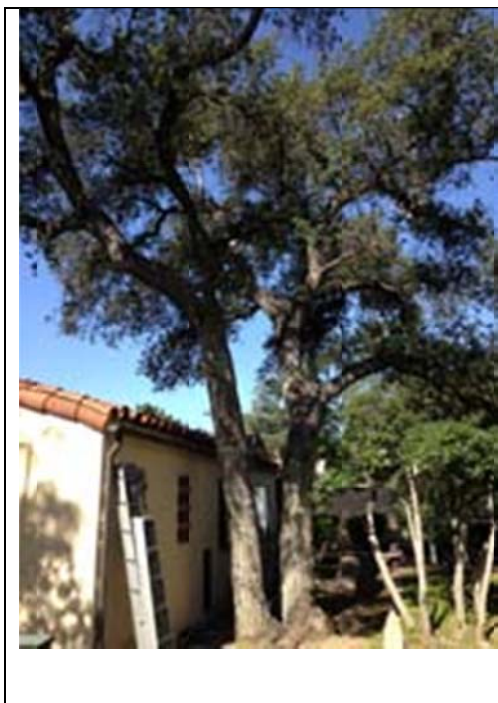
<p>Tree #61.2 <i>Ulmus parvifolia</i> – Chinese Elm</p> <p>This Elm tree is growing together in a tight grove with two <i>Pittosporum</i> trees and a young Coast Live Oak. The Chinese Elm will dominate this site if not kept under control. The Coast Live Oak will continue to grow out from under the canopy of the dominating Chinese Elm towards Hermosa Avenue. If it is desired, a harmony prune could allow clearance for the Coast Live Oak to get established on site while still permitting the Chinese Elm to have a balanced canopy. If this grove is left to benign neglect, the Coast Live Oak will likely not become an enduring specimen on the site. Rather, the Chinese Elm will be the dominant tree.</p>

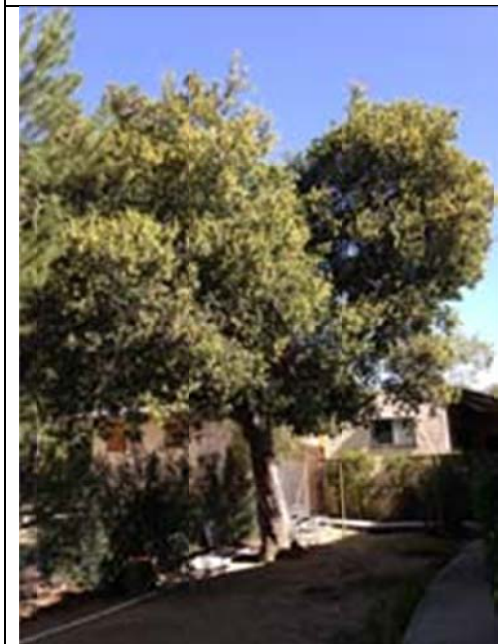
<p>Tree #63 <i>Quercus agrifolia</i> – Coast Live Oak</p> <p>This Coast Live Oak is looking a little sparse. It is likely that historical conflicts with the surrounding infrastructure have led to a restricted root system. This has caused the canopy to gradually retreat. As much foliage should be retained on the tree as possible to give the tree a chance to recover.</p> <p>There is a large old excision wound at the root crown of the tree where one of the trunks was removed a few years ago. There are no signs of cambium advancing to cover this wound site yet. There's bark loss around the former excision, but there is no active decay present yet.</p> <p>This tree should be inspected annually for defects in the limbs above the adjacent building. I observed no limb defects from the ground on the date of my site inspection.</p>

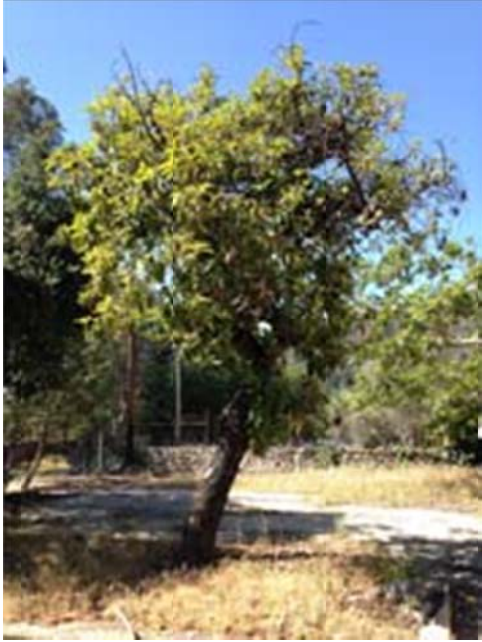
<p>Tree #67 <i>Quercus agrifolia</i> – Coast Live Oak</p> <p>This is a healthy specimen of Coast Live Oak. The foliage is healthy and shoot elongation is normal. There are cambium growth cracks in the bark, indicating tissue deposition. This tree is not growing as vigorously as its neighbors. The low fringe should be raised periodically for clearance. Deadwood should be removed from the canopy every 2 to 5 years.</p>

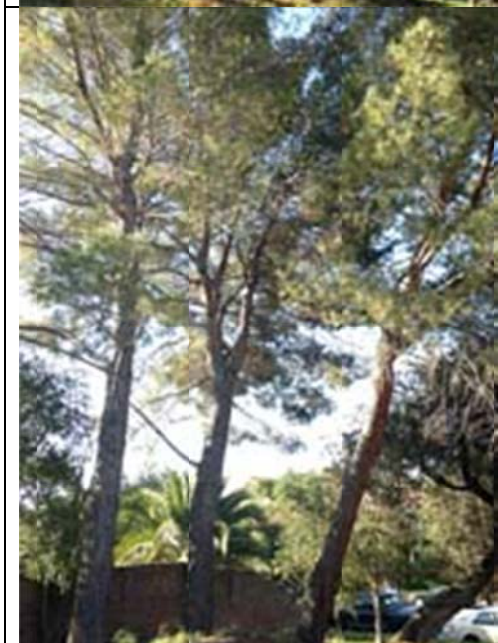
Tree #91
Pinus halepensis – Aleppo Pine

Tree #91 is an Aleppo pine with a co-dominant leading form. This form is susceptible to tear out, and the hazard could be mitigated with a safety line. However, since this tree is located in an area that doesn't receive much foot-traffic, the hazard might be tolerated in the landscape until a time when Rockhaven gets more visitors. The landscape managers should evaluate their risk tolerance for this defect.

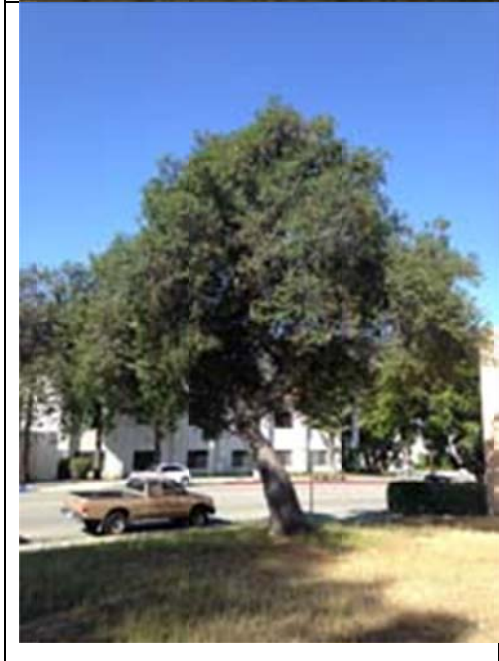
<p>Tree #96 <i>Quercus agrifolia</i> – Coast Live Oak</p> <p>Fill soil has accumulated around the base of this tree and has buried the root crown flair. This could pose a problem for the tree by encouraging decay organisms to attack the root crown. Coast Live Oak is particularly susceptible to such an attack. If possible, the fill soil should be gently removed to expose the root crown flair to air. Doing this will reduce the likelihood of fungal infections such as Phytophthora and Armillaria.</p> <p>The canopy of this tree is healthy and vigorous. There are many branches that are in contact with the adjacent building to the west. Care should be taken to proactively prune for roof clearance before the adjacent building's owner takes action.</p>

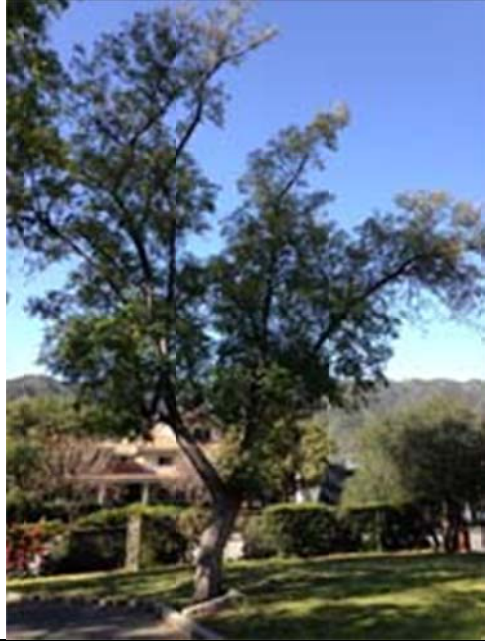
<p>Tree #97 <i>Quercus agrifolia</i> – Coast Live Oak</p> <p>This tree has great form and is in good health. There are growth cracks on the trunk that indicate vigor. The foliage is green and dense.</p> <p>On the western side of the root crown, there is a flat spot on the trunk. There is a vertical crack along this flat spot with different colored bark. This is indicative of a possible internal defect. This pattern typically develops when an old wound fully heals over and closes. This is a very old wound that may or may not have a significant impact on the tree's structural stability. It should be monitored to see if any signs of structural deficiency develop. No action needs to be taken at this time.</p>

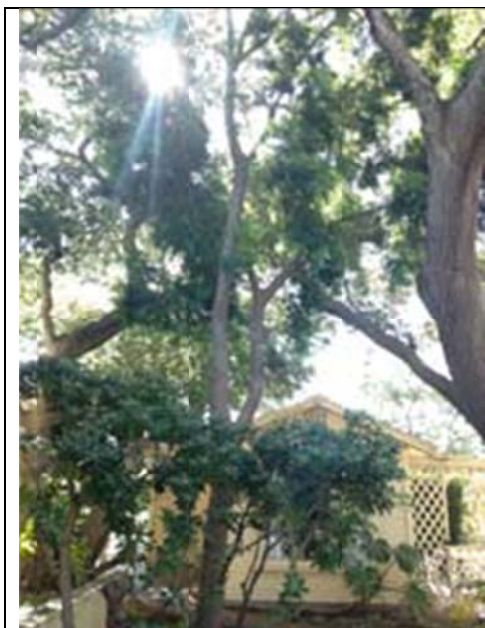
<p>Tree X <i>Pinus radiata</i> – Monterey Pine</p> <p>This young Aleppo Pine will quickly outgrow its available root space. The planter box will crack from the force of the expanding roots. A decision should be made whether to preserve this tree or the planter. The tree is in good health and should have some gentle structural pruning to train it into a long-term form if the tree will be retained.</p> <p>The tree has a co-dominant trunk form, but the angle of attachment of the two trunks is sufficiently large that it does not pose a problem at this time.</p>

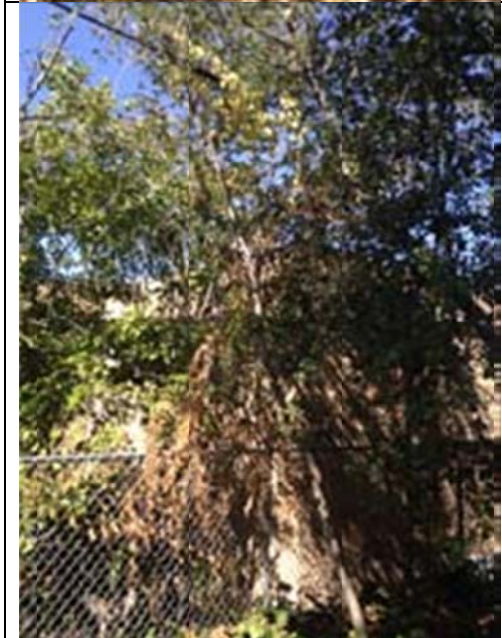
<p>Tree BA <i>Quercus agrifolia</i> – Coast Live Oak</p> <p>This young oak is doing well on site. There are growth cracks that indicate the tree is vigorously growing and expanding. This tree will need to be addressed for conflict with the power lines above it. The southern trunk is growing directly into the power lines, and several of the branches have become intertwined with the low telephone lines. This trunk should be removed, and the tree should be trained to the north, away from the power lines.</p>

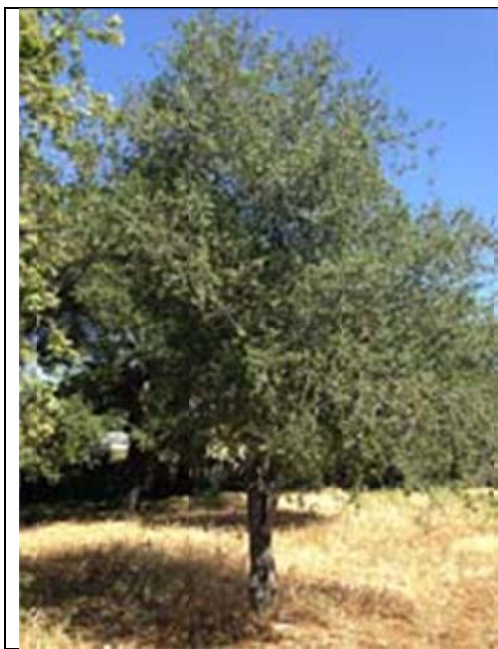
<p>Tree BB <i>Quercus agrifolia</i> – Coast Live Oak</p> <p>This juvenile volunteer oak has unfortunately started a growth pattern in an undesirable location. Nearly all of its growth is concentrated in the power lines. If the tree were pruned for power line clearance, too much of its live foliage would have to be removed for it to be useful in the landscape. I recommend considering this young tree for removal before it becomes a problem. It is currently small enough that it is not protected by the City of Glendale oak tree protection ordinance.</p>

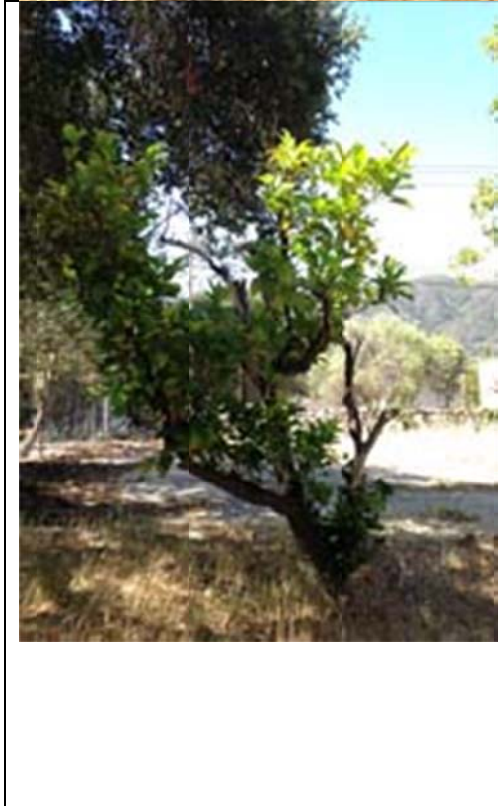
<p>Tree BC <i>Quercus agrifolia</i> – Coast Live Oak</p> <p>This young oak could have a few form corrections to improve its longevity in the landscape. There are several crossing branch structures that should be pruned to subordinate to the more desirable scaffold.</p> <p>There is a wound on the southeastern side of the root crown that has almost fully healed. The tree will retain this defect for the rest of its life, but it does not appear to have any long-term detrimental effects to the tree. There are many growth cracks along the trunk, indicating the tree is still vigorous and depositing new tissue rapidly. The foliage looks healthy.</p>

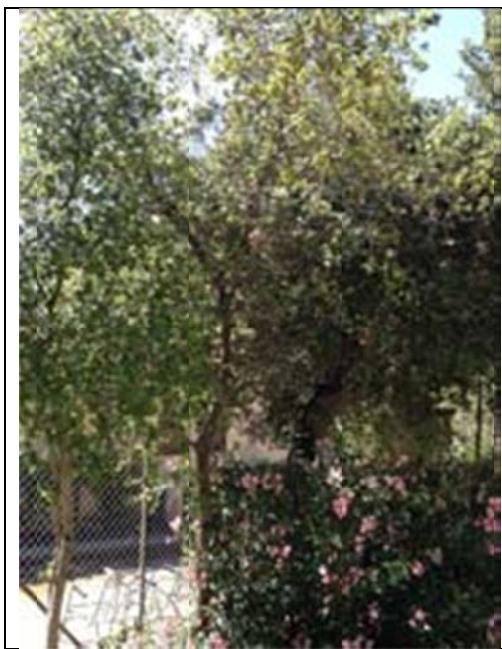
<p>Tree BG <i>Citrus sinensis</i> – Orange Tree</p> <p>In the past, this orange tree was chopped back on all of its scaffold branches. Because citrus does not handle topping cuts well, it nearly died. However, the tree has subsequently sprouted new adventitious shoots along a few of its scaffold branches. It is possible to restore the tree using these shoots. All of them should be preserved for now, and in a few years they should be thinned and trained to the new scaffold of the tree. The dead branches can be removed for aesthetic purposes.</p> <p>As a result of the tipping cuts on the tree, bark loss has advanced down the main trunk, and the tree is only able to use about half of its former vascular potential. Citrus is a poor healer, so it may take many years for these wounds to heal if they ever do. Fortunately, citrus trees also have natural defenses against decay organisms, so that should buy the tree some time to mount a recovery.</p>

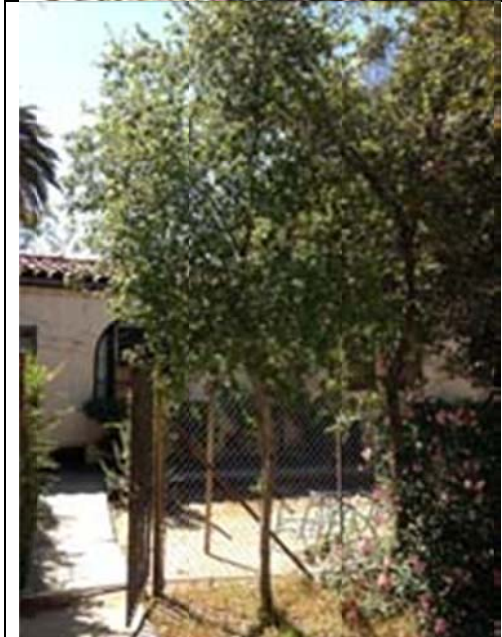
<p>Tree BH <i>Quercus agrifolia</i> – Coast Live Oak</p> <p>This young oak is growing well on site. There is some minor deadwood in the canopy from natural shade out dieback. There are a few growth cracks indicating that the tree is healthy and depositing new tissue. Eventually, this tree may conflict with the adjacent chain-link fence. This will not be for some time, so no action is necessary now.</p>
