TREE INVENTORY

Prepared for Leisure World Mutual 17 Seal Beach, CA

Prepared by JAMES KOMEN – CLASS ONE ARBORICULTURE BOARD CERTIFIED MASTER ARBORIST #WE-9909B REGISTERED CONSULTING ARBORIST #555 (818)495-5344 CLASSONEARBORICULTURE@GMAIL.COM OCTOBER 18, 2014

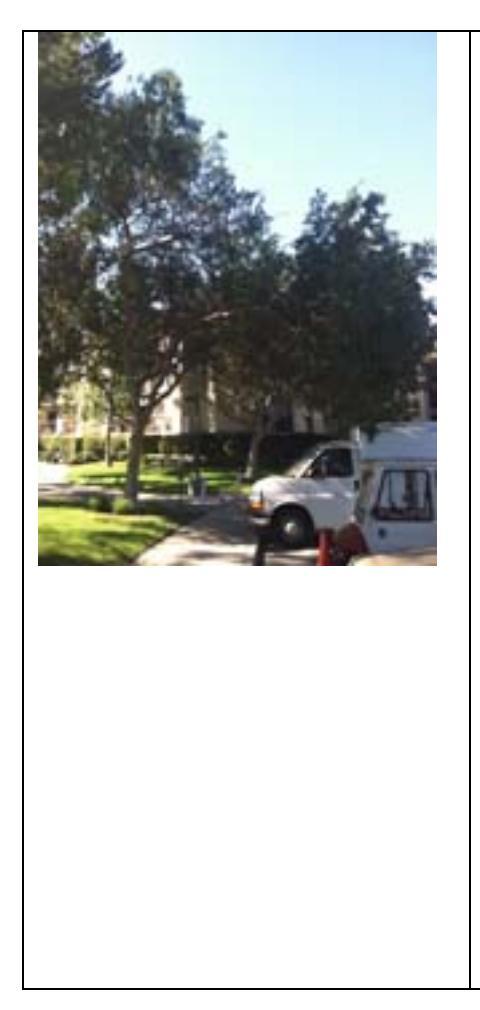
Site 1 *Ulmus parvifolia* - Chinese Elm

This Chinese Elm is afflicted with the Chinese Elm anthracnose canker. The canker has split open the living bark tissue on many of the scaffold branches and has left a substantial wound site at the base of the tree on the eastern side. The wound is not large enough to raise a concern over a structural deficiency in the tree at this time, but it should be monitored annually.

One of the large scaffold branches leaning out to the northwest carries approximately 75% of the canopy weight. This part of the canopy should be thinned to reduce the likelihood of this branch tearing out and falling on a vehicle parked below. Before thinning healthy branches, the defective and diseased branches should be removed from this section of the canopy, and no more than 15% of live foliage should be removed in any given year.

Maintenance: 45 min. Next Service: now Priority: high

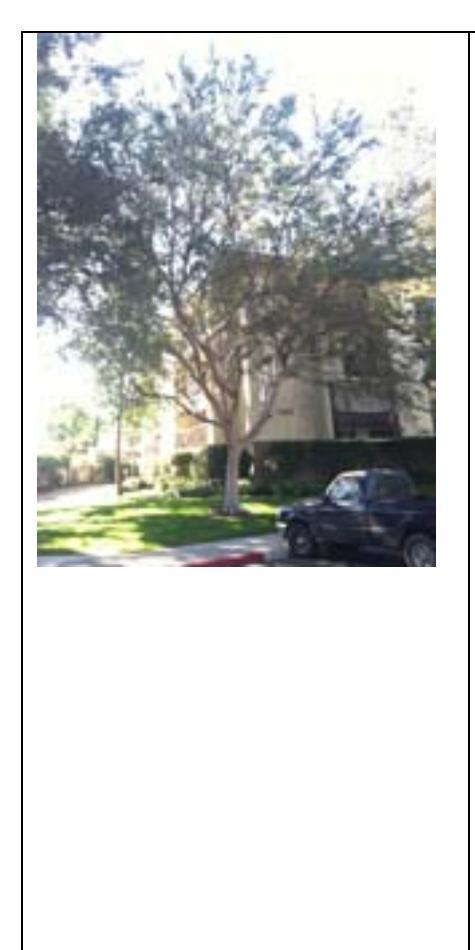
Site 2 *Ulmus parvifolia* - Chinese Elm

This tree has a substantial canker on the south side, approximately 5 feet up the trunk. One of the main scaffold branches pointing to the south will likely fail in a matter of years if not removed. There are two scaffold branches pointing to the south: the lowest one should be removed this year, and the upper one should be inspected next year to assess for possible removal.

In addition to the anthracnose canker on this tree, there is some substantial squirrel chew that is older than the canker. Around the squirrel chew wounds, the tree is depositing new cambium tissue that will eventually heal. This contrasts with the anthracnose cankers that are increasing in size as the bark of the tree retreats. This tree should be inspected annually for hazard potential, but it can be retained in the landscape at this time.

Maintenance: 30 min. Next Service: spring Priority: medium

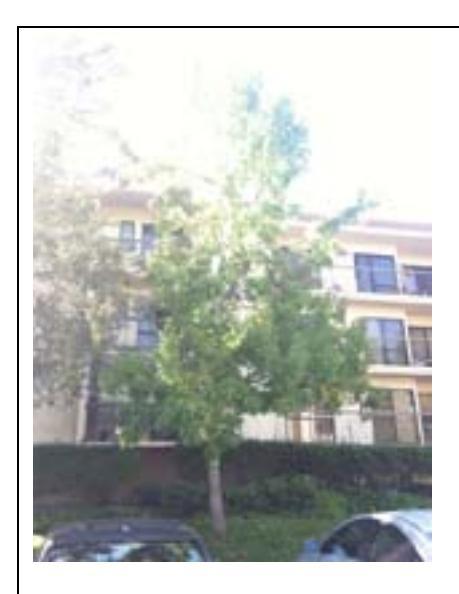
Site 3 *Liquidambar styraciflua* - American Sweet Gum

This liquidambar is an attractive choice of tree for this site for aesthetics, but it is already beginning to cause problems with its roots. There is evidence of roots lifting the adjacent sidewalk, and these problems will continue as long as this tree is located here. Cutting the roots or installing a root barrier is not an option because the severing of this tree's anchorage roots would predispose it to falling to the south onto adjacent building. Rather, a decision should be made on whether to keep the tree or to grind the sidewalk every few years.

There are ties that are impounded in the trunk from when the tree was planted. The ties that affixed the tree to its stake were never removed, and now they constrict the trunk, creating a weak spot approximately 4.5 feet up the trunk. These ties can't be removed at this time without causing further damage, so they should be retained. This weak spot on the trunk should be monitored annually, and if it is determined to be a hazard, the tree may need to be removed and replaced. Currently the tree does not pose an imminent hazard.

Maintenance: 15 min. Next Service: winter Priority: medium

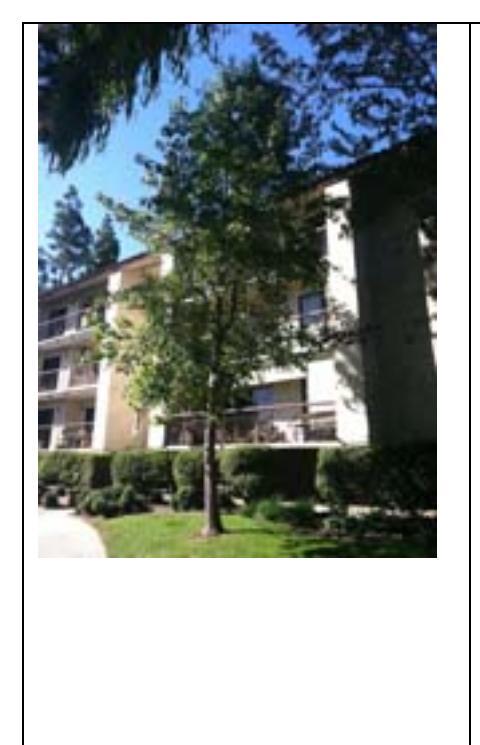
Site 4 *Liquidambar styraciflua* - American Sweet Gum

This tree is an excellent aesthetic choice for this location because it is a tall tree planted on the eastern side of the apartment building, and it will protect the northernmost corner of the building from the eastern morning sun. Unfortunately, this tree species is somewhat root aggressive and will eventually cause the adjacent sidewalk to lift and buckle. A decision should be made on whether the tree should be retained or replaced. If retained, the sidewalk will need to be ground down every few years to reduce trip hazards.

The tree has a co-dominant lead at approximately 10 feet up the trunk. This tree is young enough that the western co-dominant stem could be removed without causing major harm to the tree. If it is to be retained, then a safety line should be installed to mitigate the hazard of one of the stems failing in the wind. The tree can be retained for several more years without installing a safety line. There are a few low branches that should be raised for clearance annually.

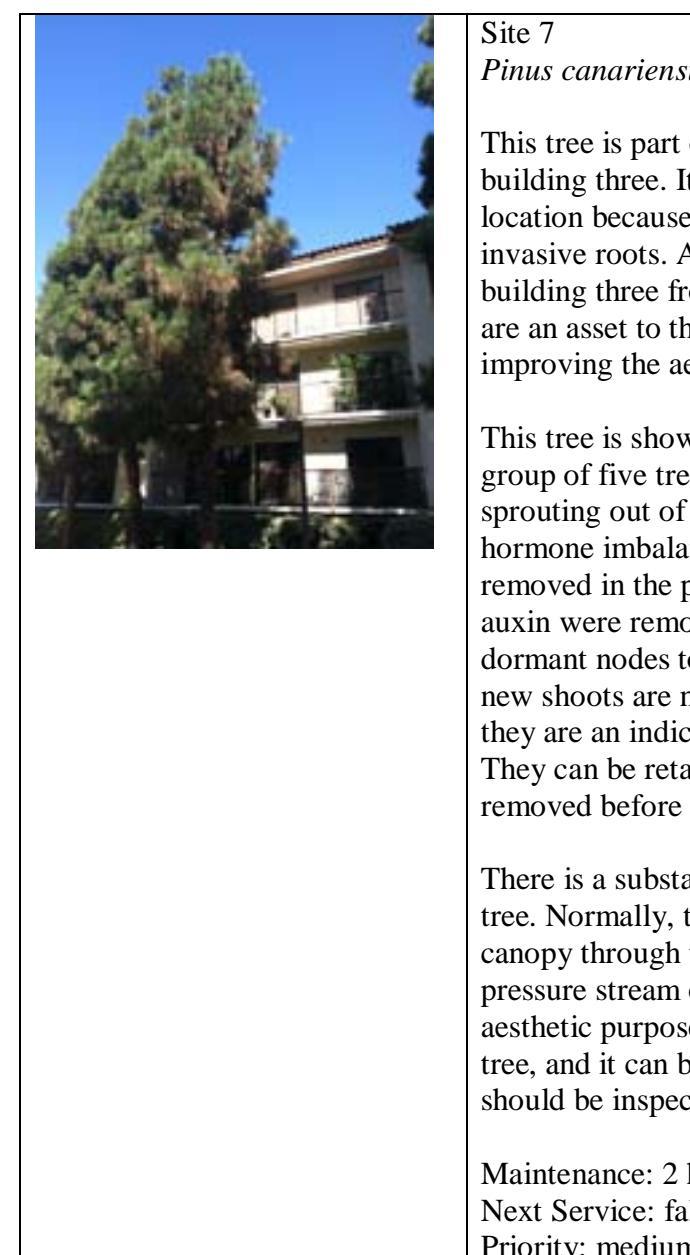
Site 7 *Pinus canariensis* - Canary Island Pine

This tree is part of a stand of five trees on the southern face of building three. It is an excellent choice of species for the location because it grows tall but does not have particularly invasive roots. All five of these trees shade the southern face of building three from exposure to the hot midday sun. These trees are an asset to the building by reducing cooling costs and improving the aesthetic appearance of the building façade.

This tree is showing the greatest hormonal response of this group of five trees. There are many adventitious shoots that are sprouting out of the trunk of the tree as a result of a plant hormone imbalance. When the tips of the branches were removed in the past, the production sites of the plant hormone auxin were removed. This imbalance in hormones caused the dormant nodes to respond by exploding into new growth. These new shoots are neither a problem nor an asset to the tree; rather, they are an indicator of stress further up the trunk of the tree. They can be retained for now, but they should eventually be removed before they compete with the permanent scaffold.

There is a substantial load of dead needles in the canopy of this tree. Normally, these needles are naturally dislodged from the canopy through the force of wind, but if it is desired, a highpressure stream of water can knock them out of the canopy for aesthetic purposes. There are no apparent hazard features on this tree, and it can be retained in the landscape at this time. The tree should be inspected annually by a climber for defects.

Maintenance: 2 hours with climber Next Service: fall Priority: medium

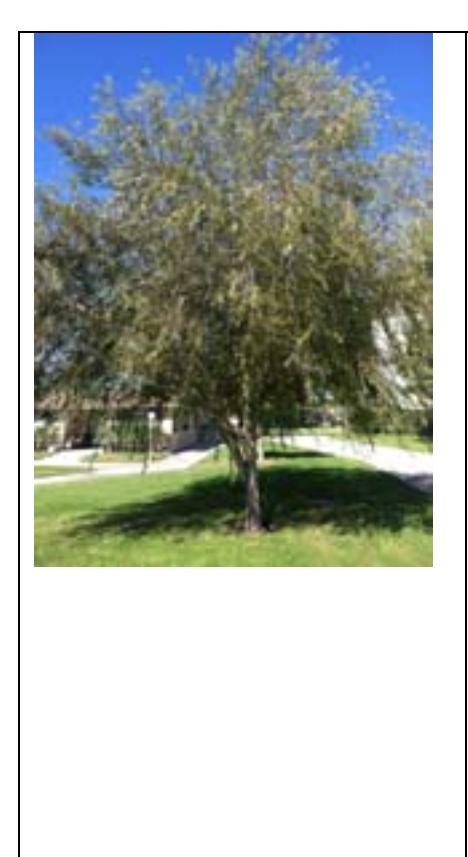
Site 13 Salix babylonica - Weeping Willow

This tree will become a beautiful landscape asset as it matures. It is a riparian species that is tolerant of occasional flooding. However, one major problem is the species' root aggressiveness. It is located near a storm drain and a driveway; its roots will eventually grow under these pieces of hardscape and cause it to lift and buckle. It is possible at this early stage to install a root barrier to preemptively deter the roots from growing under these surfaces. Root barriers do not prevent root growth, but they do slow it.

It is time for the canopy to be trained. There are many crossing branch defects that should be corrected. The fringe should be raised around the crown for head height clearance. The low interior twigs can be cleaned out to leave a more aesthetically appealing trunk form.

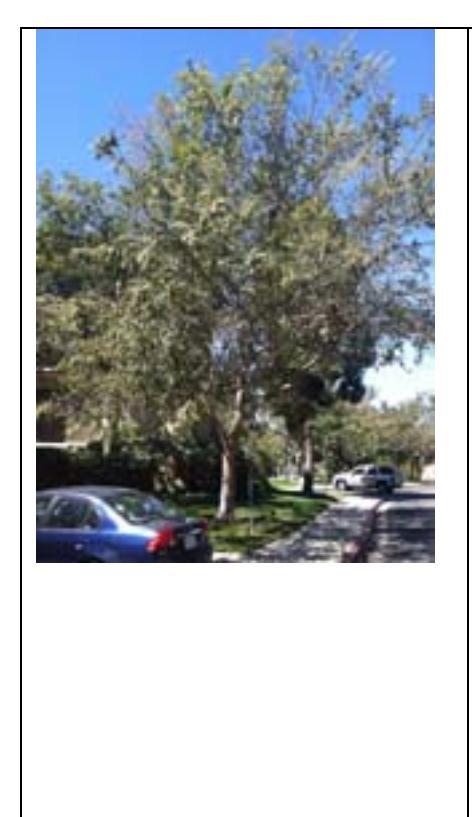
Site 53 *Ulmus parvifolia* - Chinese Elm

This Chinese Elm has Chinese Elm anthracnose canker. There is a branch union about 10 feet up the southern scaffold branch that has a large canker covering the western half of the branch union. This is likely a weak spot that is susceptible to branch breakage. The branches that emanate from this union have dense concentrations of foliage at the tips and are in high cantilever. The foliage on these tips should be reduced and thinned to reduce the weight load on this structure. If the structure fails, then it should be cut back to the next main stem. Failure of this trunk would not hit a car or the building; therefore it can be retained at this time. There is some minor deadwood scattered throughout the canopy that should be removed. The branches over the street should be pruned for clearance.

There are a few dead stumps that remain on the tree from the previous time it was pruned. These stumps should be removed so that the tree can begin to heal those wounds. There is also some foliage on the eastern side of the tree that is in heavy cantilever over the parking area. These branches should be thinned to reduce the likelihood of branch tearout and failure onto a car.

Maintenance: 45 min. Next Service: winter Priority: high

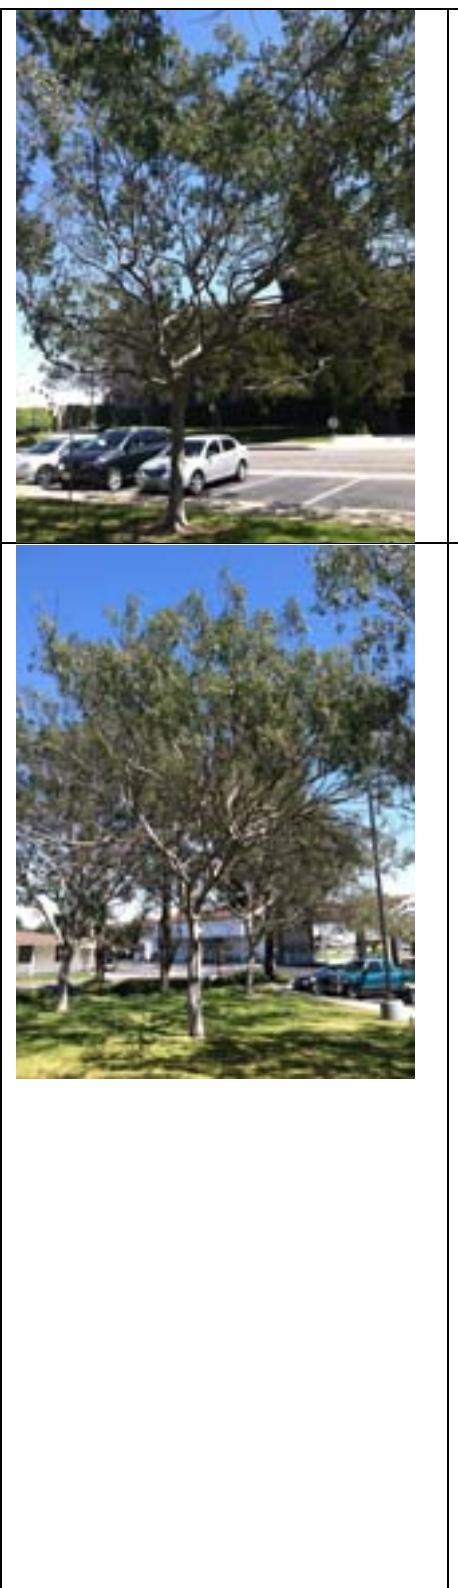
Site 74 *Ulmus parvifolia* - Chinese Elm

This tree has deadwood scattered throughout the canopy that should be removed. Its fringe should be raised over the parking area. The interior scaffold has a fairly good structure. No live wood should be removed from the tree at this time because the tree is currently stressed. Aside from pruning for clearance, no live wood should be removed from the tree at this time.

The turfgrass is growing all the way to the trunk of this tree. In the course of maintaining the turfgrass, a weed whacker was used to shorten the grass around the trunk of the tree. The weed whacker has damaged the outer bark of the tree around the root crown and has likely stressed the tree. It is very possible that these wounds inflicted by a string trimmer will ultimately cause the death of the tree. They should continue to be monitored. When significant decay enters through this section of the tree, it may need to be marked as structurally deficient and replaced. Until then, deadwood should be removed and live wood should be retained.

Maintenance: 30 min. Next Service: winter Priority: medium

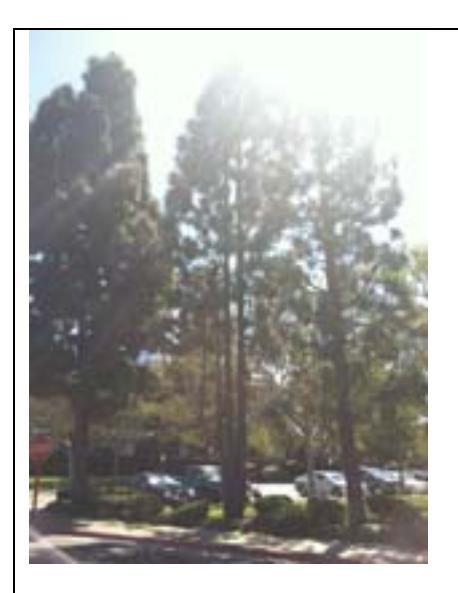
Site 79 *Pinus canariensis* - Canary Island Pine

This Canary Island Pine was over-pruned in the past. Many of the lateral branches were cut back to stumps, reducing the production of a plant hormone called auxin. Auxin controls the dormancy of adventitious shoots, and so its absence has resulted in prolific sprouting up and down the trunk of the tree. These shoots should be allowed to grow at this time but they will need to be removed after one to two years before they create an undesirable scaffold structure.

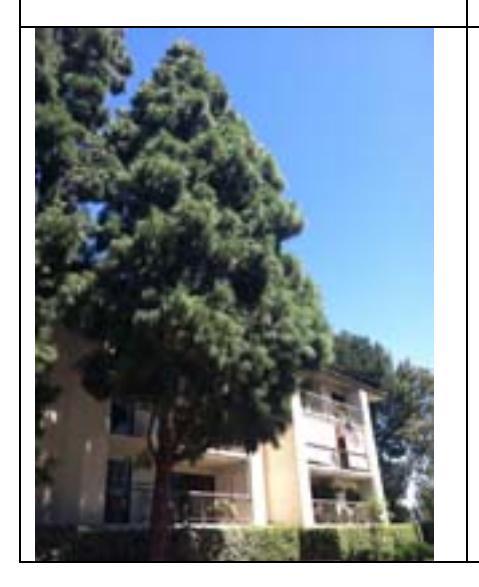
Site 92 *Pinus canariensis* - Canary Island Pine

This tree has a smaller co-dominant stem to the east that can be gradually reduced from the top down. It is not a concern for hazard, but it could turn into one in the next five years if not destimulated. While climber is in the tree de-stimulating the codominant stem, he should also inspect the tree for any possible defects.

Maintenance: 3 hours with climber Next Service: winter Priority: medium

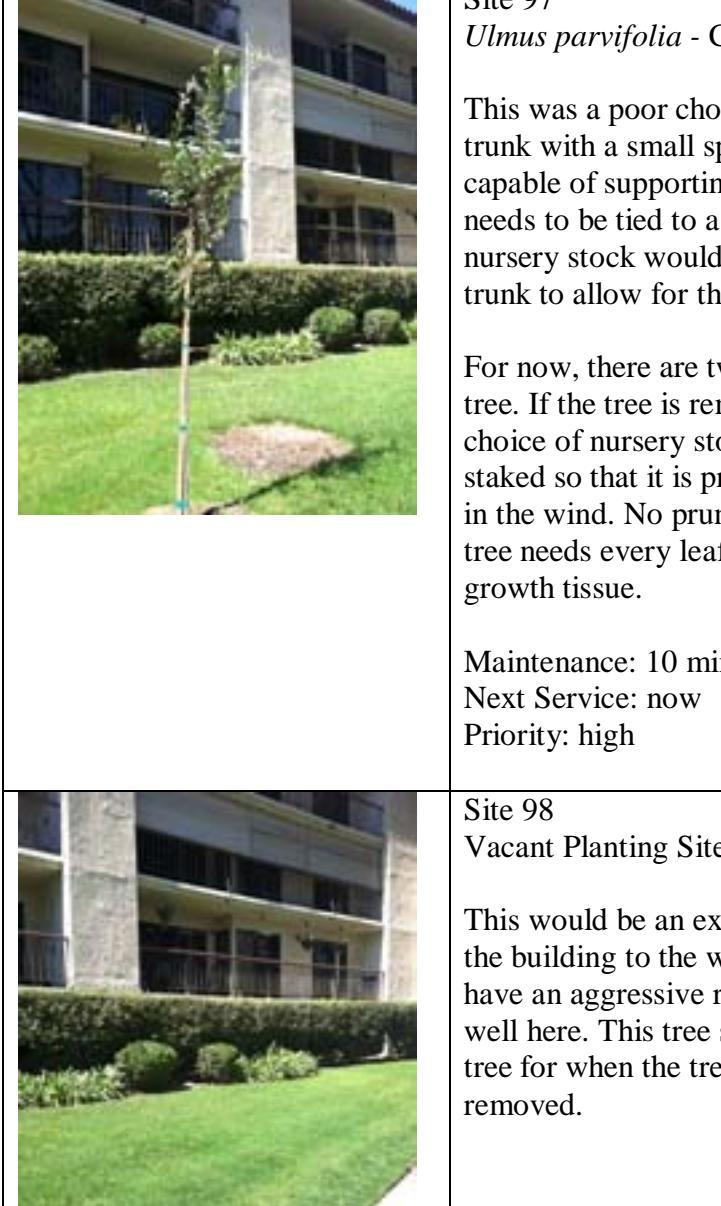
Site 97 Ulmus parvifolia - Chinese Elm

This was a poor choice of nursery stock. It has a small, thin trunk with a small sprig of foliage at the top. The trunk is not capable of supporting the tree's own weight and it therefore needs to be tied to a stake. The ideal form for this tree from nursery stock would have low branching all the way down the trunk to allow for the development of trunk taper.

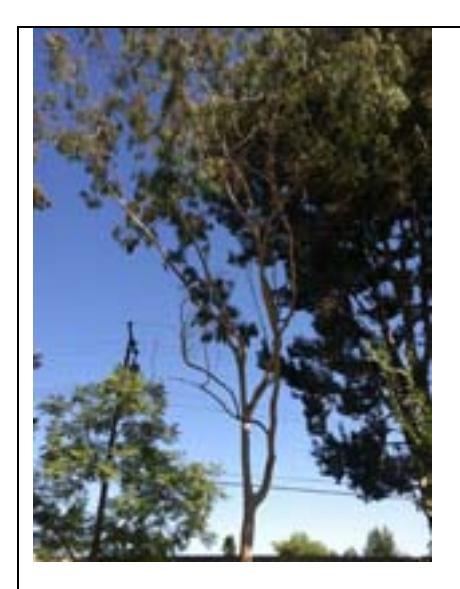
Site 119 Corymbia citriodora - Lemon Scented Gum

This tree is located approximately 7 feet from the newly installed wall. It is also immediately adjacent to one of the primary access ways for machinery to get to the wall construction site. This means that the soil near the root crown of the tree on the southern side was compacted by the passing machinery. Because of the soil compaction damage, the tree may have lost a significant portion of its root system due to construction. The roots on the south side of the tree will be inhibited due to the reduction of soil pore space from soil compaction, and the roots to the east were lost because they were severed when the trench was dug.

Maintenance: eight hours with climber Next Service: winter Priority: high

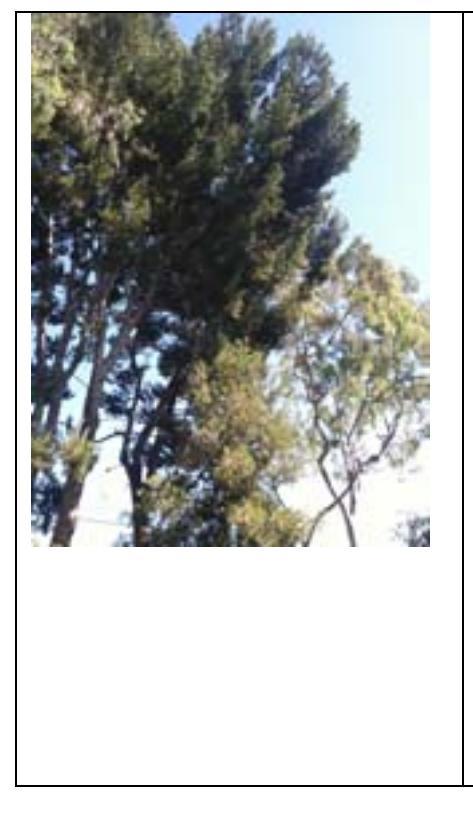
Site 121 Pinus halepensis – Aleppo Pine

This tree's trunk is located approximately 4 feet from the adjacent wall. Its lowest branches have been cut to stumps on the side of the power lines for line clearance. These branches will eventually die back to the main stem and need to be removed, leaving an imbalance in the tree's canopy to the west. Because of the westerly imbalance in the tree's canopy and absence of eastern tensile buttress roots, this tree is a falling hazard. However, if it were to fall to the west, it has no target except adjacent trees and a walkway. For this reason, it may be considered to be retained for some time the landscape until defects appear.

Maintenance: four hours with climber Next Service: winter Priority: high

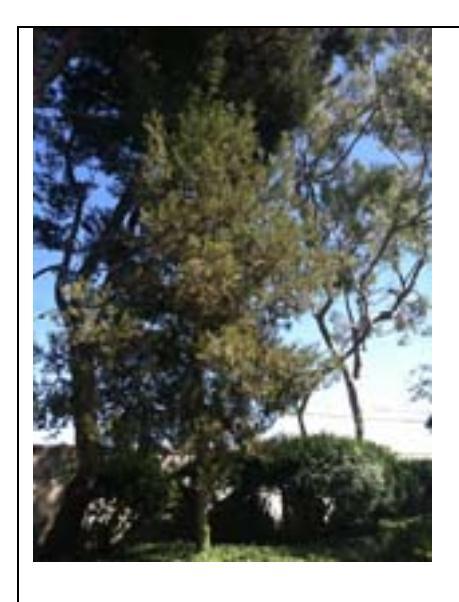
Site 122 *Pinus halepensis* – Aleppo Pine

This young Aleppo Pine is sufficiently far from the newly installed wall that it did not suffer significant root damage. There is a protective layer of ivy growing around the root zone of this tree, and there is no indication of soil compaction in the recent past. Therefore, this tree can be retained in the landscape. The ivy growing up the trunk of this tree should be removed before it colonizes the tree. Care should be taken to not damage the bark when the ivy is removed.

Maintenance: 2 hours with climber Next Service: winter Priority: medium

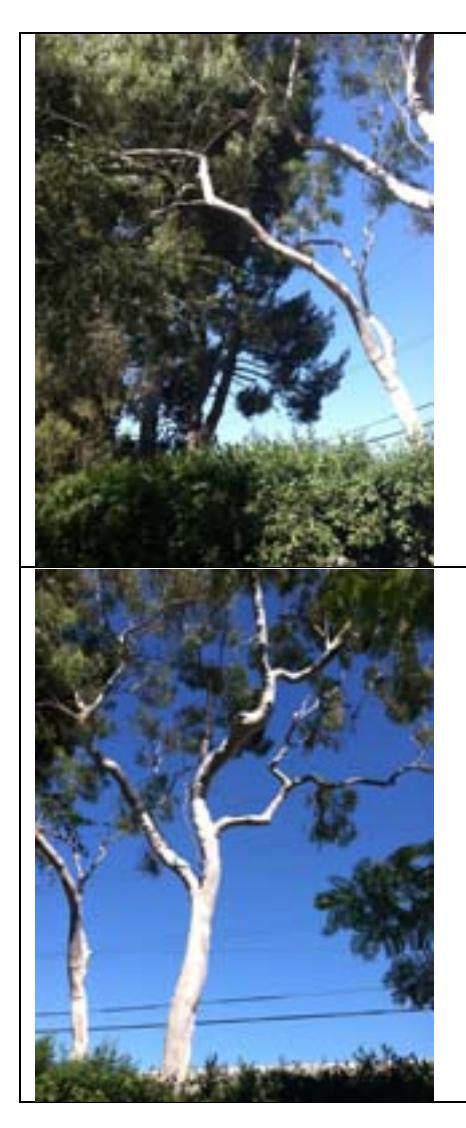
Site 123 Corymbia citriodora – Lemon Scented Gum

This tree is about 5 feet from the newly constructed wall. Like its neighbors, it is predisposed to failing to the west due to root cutting. It has some minor deadwood that can be removed for aesthetic purposes. This tree does not have a target to the west, so it can be retained until it fails.

Maintenance: one hour with climber Next Service: spring Priority: medium

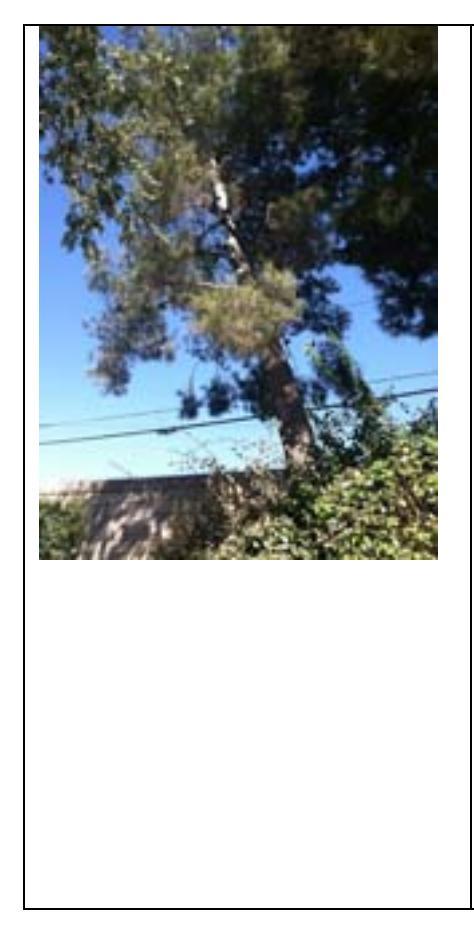
Site 125 Pinus halepensis – Aleppo Pine

This tree has a prevailing lean to the north away from the tree at Site 126 that dominates this grove. Its trunk is located approximately 9 feet from the newly installed wall.

Maintenance: two hours with climber Next Service: 2016 Priority: high

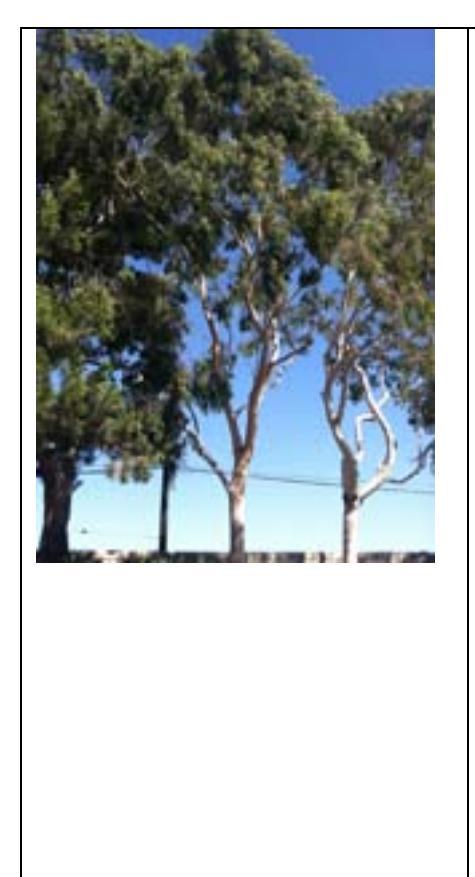
Site 128 Corymbia citriodora – Lemon Scented Gum

This tree is located approximately 4 feet from the recently constructed wall. The center of gravity for this tree is to the west, away from the wall. Much of the pruning on this tree has trained it to grow to the west. This shifted center of gravity makes the tree more susceptible to fail to the west over the parking lot.

Consider Removal

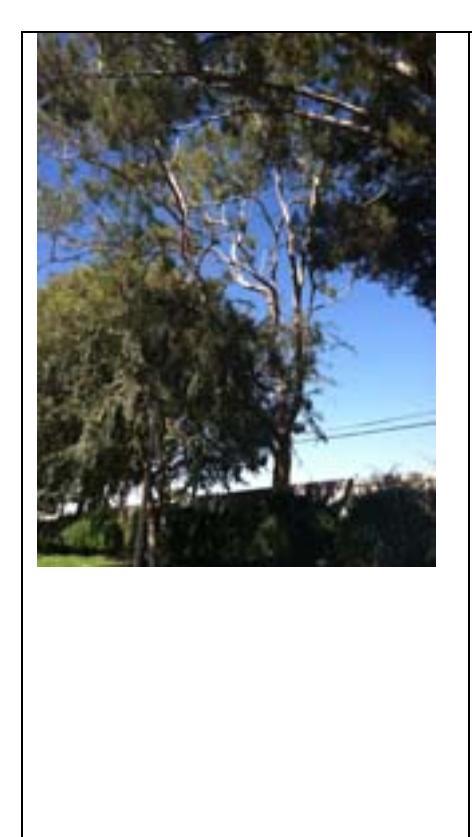
Site 131 Corymbia citriodora - Lemon Scented Gum

This lemon scented gum is located approximately 4 feet from the recently installed wall. There are several surface buttress roots that terminate at the wall; they must have been severed when the wall was built. These surface buttress roots formerly carried much of the support weight of the tree from failing to the west. With these gone, the holding capacity of the remaining root system is significantly diminished.

Maintenance: three hours with climber Next Service: winter Priority: high

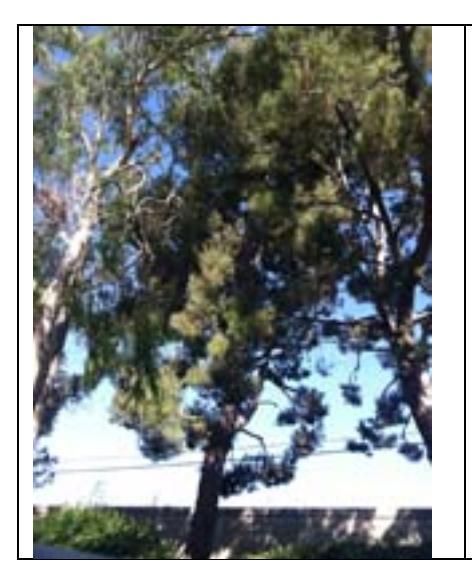
Site 136 *Pinus halepensis* - Aleppo Pine

This tree is about 5 feet from the newly installed wall. There are some large above-ground roots that terminate at the wall, indicating that there was major root cutting on this tree. There are some chalk markings at the base of the tree, possibly indicating that this tree was already marked for removal. The size of these severed anchorage roots makes this tree a hazard in the landscape. I recommend its removal.

Removal recommended.

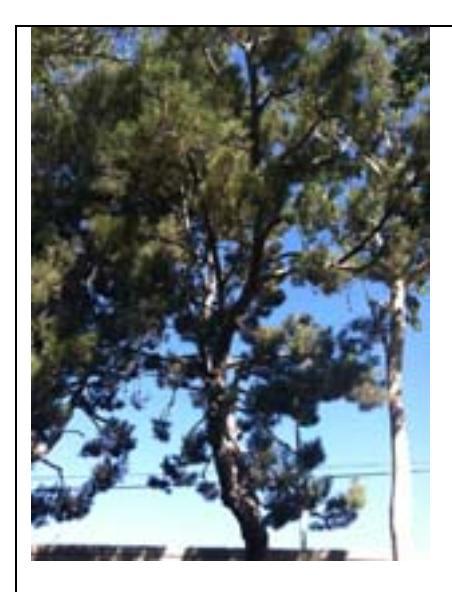
Site 137 *Pinus halepensis* - Aleppo Pine

This pine tree is less than 3 feet from the newly installed wall. It most certainly has lost a large portion of its root system when the wall was installed. There are no above-ground signs of root cutting, but the proximity of the tree to the wall implies the inevitability of such root cutting.

Maintenance: two hours with climber Next Service: 2016 Priority: medium

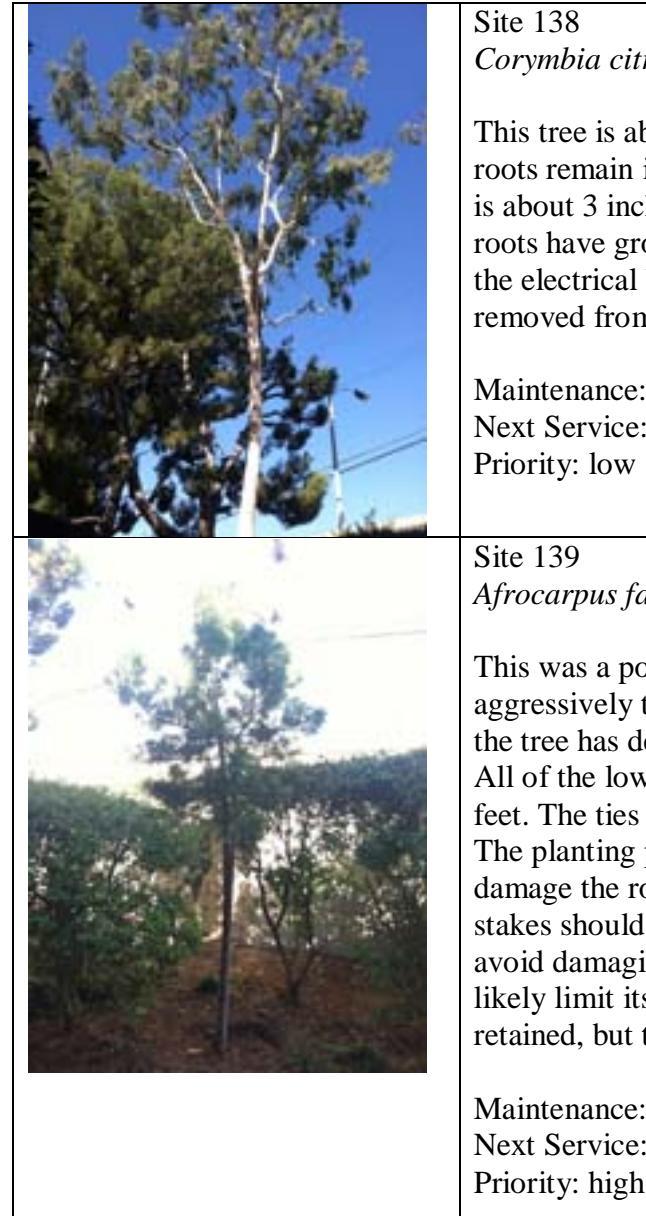
Corymbia citriodora - Lemon Scented Gum

This tree is about 6 feet from the adjacent wall, and enough of its roots remain intact so the tree can be retained in the landscape. It is about 3 inches from an electrical box, and it is likely that the roots have grown around and underneath the concrete slab for the electrical box. There is some minor deadwood that can be removed from the tree for safety and aesthetic purposes.

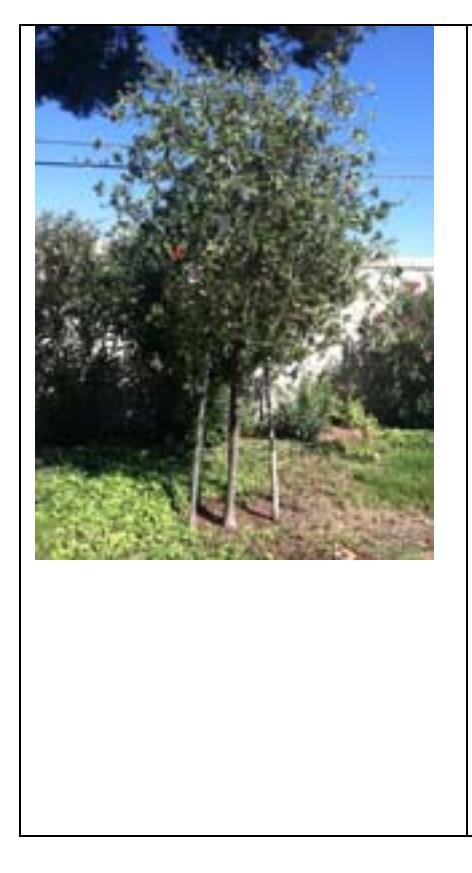
Site 147 *Callistemon citrinus* – Lemon Bottlebrush

This newly installed bottlebrush was not impacted by the installation of the eastern wall.
