TREE INVENTORY

Prepared for Leisure World Mutual 17 Seal Beach, CA

Prepared by JAMES KOMEN – CLASS ONE ARBORICULTURE BOARD CERTIFIED MASTER ARBORIST #WE-9909B REGISTERED CONSULTING ARBORIST #555 (818)495-5344 CLASSONEARBORICULTURE@GMAIL.COM OCTOBER 18, 2014

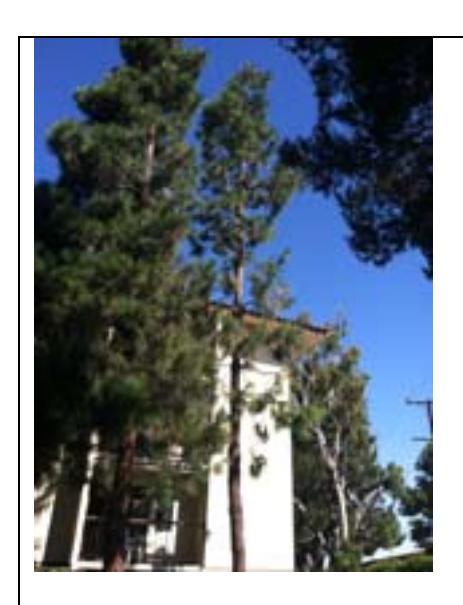
Site 5 *Pinus canariensis* - Canary Island Pine

This tree is part of a stand of five trees on the southern face of building three. It is an excellent choice of species for the location because it grows tall but does not have particularly invasive roots. All five of these trees shade the southern face of building three from exposure to the hot midday sun. These trees are an asset to the building by reducing cooling costs and improving the aesthetic appearance of the building façade.

This tree appears to have been pruned more aggressively than its neighbors. As a result, the growth has been stunted, and the tips have been removed from nearly all of the lateral growing branches. This tree is currently stressed, and it may end up having a shorter lifespan than its neighbors. For now, no action needs to be taken, but the tree should be inspected annually for any signs of developing structural defects.

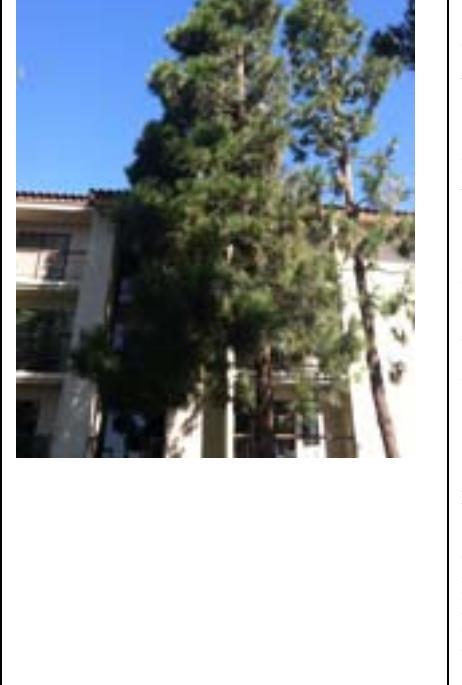
This tree has an ideal dense canopy. It should not be thinned at this time because the canopy density is damping the force of the wind on the trunk. Rather, the tree should be inspected annually for structural defects and problematic branches should be removed.

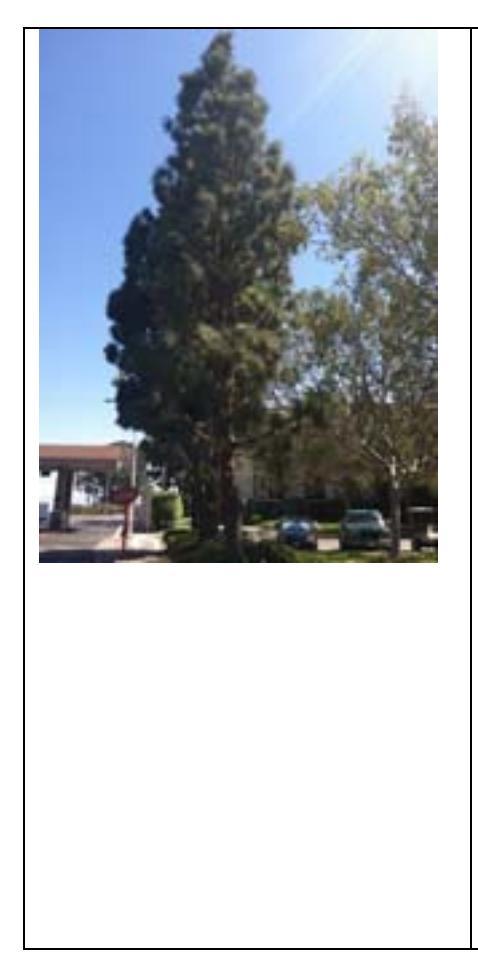
Site 78 *Pinus canariensis* - Canary Island Pine

This Canary Island Pine was over-pruned in the past. Many of the lateral branches were cut back to stumps, reducing the production of a plant hormone called auxin. Auxin controls the dormancy of adventitious shoots, and so its absence has resulted in prolific sprouting up and down the trunk of the tree. These shoots should be allowed to grow at this time but they will need to be removed after one to two years before they create an undesirable scaffold structure.

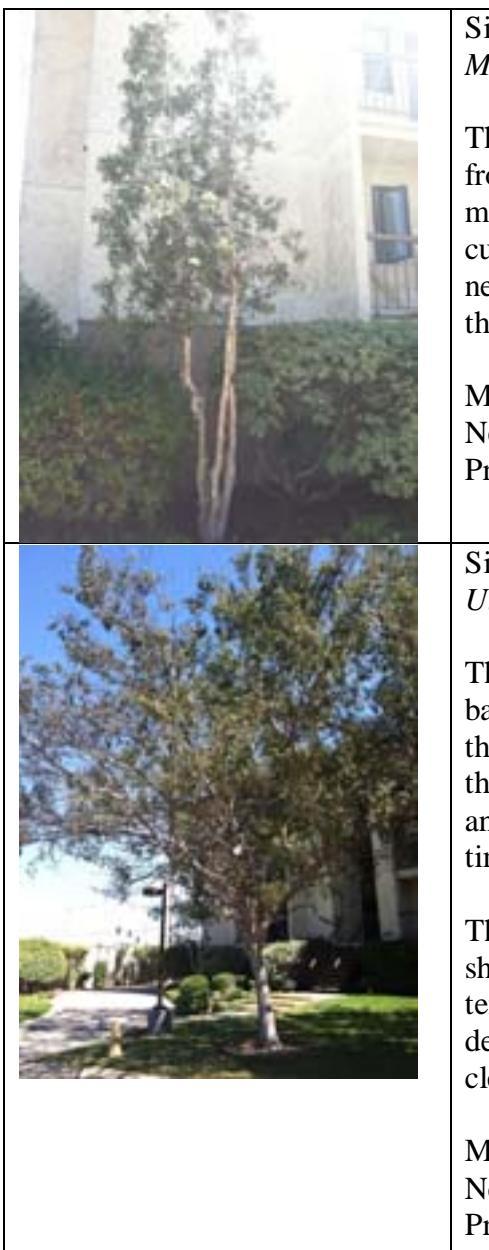
Site 81 *Melaleuca quinquenervia* – Paperbark Tree

This recent transplant is located on a good site that is protected from the morning sun. Light, selective pruning cuts should be made to keep the tree clear from the building, but these pruning cuts will not be necessary for a while. For now, the tree does not need to be pruned. The only major maintenance issue is keeping the root ball clear of debris and soil that may erode around it.

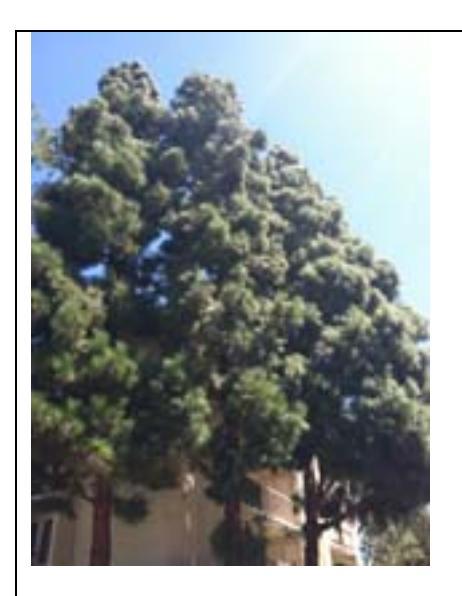
Site 91 *Pinus canariensis* - Canary Island Pine

This tree is an excellent choice of species for the location because it grows tall but does not have particularly invasive roots. The trees in this grove are an asset to the building by reducing cooling costs and improving the aesthetic appearance of the building façade. This tree is also growing epicormic shoots that are sprouting along the trunk. These shoots can be retained for now, but will need to be removed eventually for aesthetic purposes.

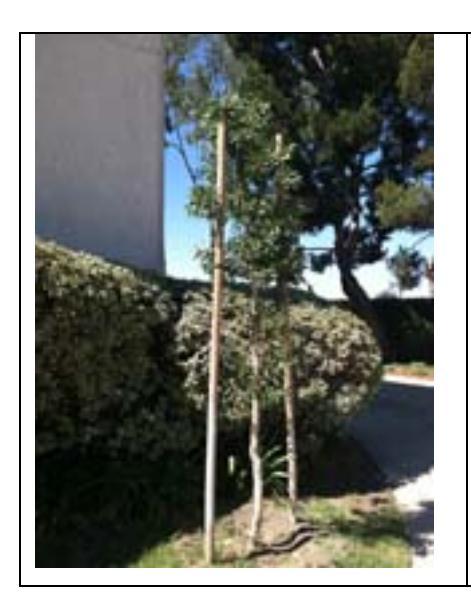
Site 109 Melaleuca quinquenervia - Paperbark Tree

This small tree is struggling on site. It has relatively low lateral branching coming out from its nearly straight trunk. The low lateral branches should be allowed to grow as much possible and fill in the canopy aesthetically. This will also help the tree develop trunk taper, making it able to stand on its own. For now, the stakes need to be retained and should be inspected by an arborist in one year.

Maintenance: 10 min. Next Service: fall Priority: low

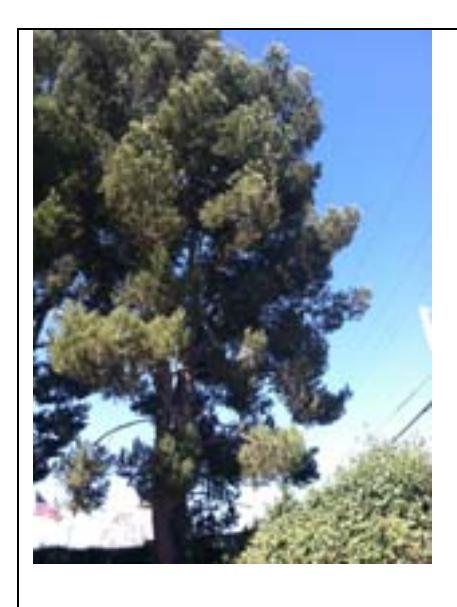
Site 113 Pinus halepensis – Aleppo Pine

The tree is located approximately 15 feet from the newly installed wall. Aboveground, the tree appears healthy and does not appear to be in decline as a result of the adjacent wall's installation. I did not observe any signs of decay in the root crown area at the time of my inspection.

The interior of this tree appears to be clean and does not need any pruning at this time. There are no limbs that are in severe cantilever, and the foliage distribution is acceptable. This tree should simply be monitored for any signs that the newly installed wall caused severe damage to its root system.

Although this pine tree has a co-dominant trunk form, the angle of attachment is sufficiently large that the weakest point on the tree is not the co-dominant union. Therefore, no action needs to be taken to correct the trunk union at this time.

Maintenance: 30 minutes with climber inspection Next Service: winter Priority: high

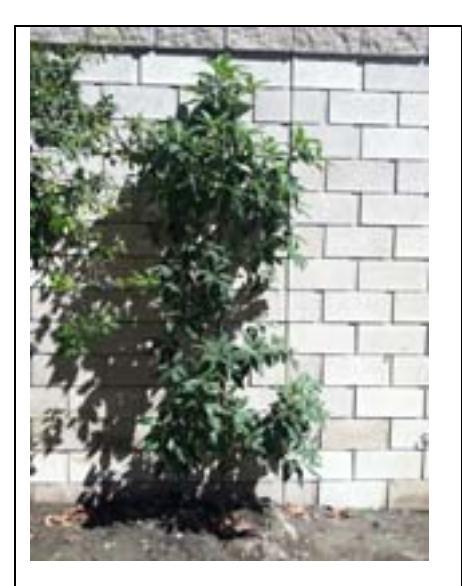
Site 114 Lophostemon confertus - Brisbane Box

This young tree was a well-chosen specimen, but it was not a well-chosen planting site. This planting site will limit the lifespan of this tree because of the limited root space. If this tree is allowed to grow into its natural form, it will push up against the newly installed wall to the east. It will also grow far taller than its neighboring hedges, creating an anomaly in the aesthetic appearance of the wall's landscaping. While it is in its youth, this tree should be transplanted somewhere it will create more value for the mutual.

Once it is planted in its final spot, the nursery stake and ties should be removed. If the tree is not able to stand on its own, the tree should be staked by two planting poles inserted in the ground outside the root ball. The tree should be allowed to sway in the wind so that it can develop trunk taper.

Maintenance: 10 min. once it is planted Next Service: winter Priority: high

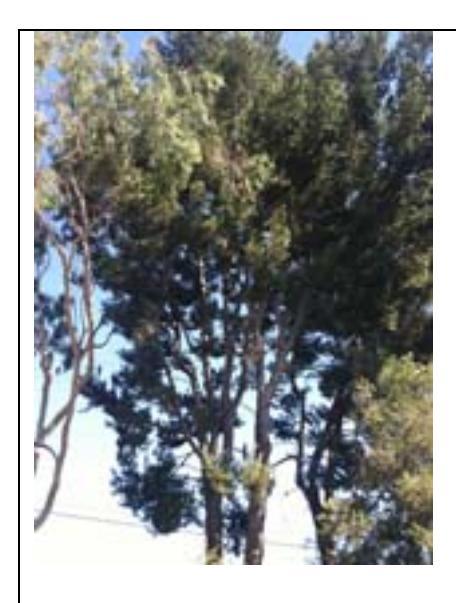
Site 120 Pinus halepensis - Aleppo Pine

This tree's trunk is located approximately 6 feet from the newly installed wall.

The canopy of the northern trunk is relatively balanced. The canopy of the southern trunk has a westerly lean, but not so much that the lean of the tree poses a hazard to the south. The northern trunk serves to counterbalance the lean of the southern trunk. The key failure region for this tree would be the root zone where the newly installed wall is.

If the tree were to fail, it would not hit the adjacent building or cause significant damage. The only target for this tree on the western side is the adjacent walkway. It is less likely that the tree would fail to the east due to the root cutting from the installation of the wall because the strongest buttress roots are the tensile buttress roots on the windward side. If the tree were to fail to the east, it would due to be due to a combination of other factors such as soil compaction.

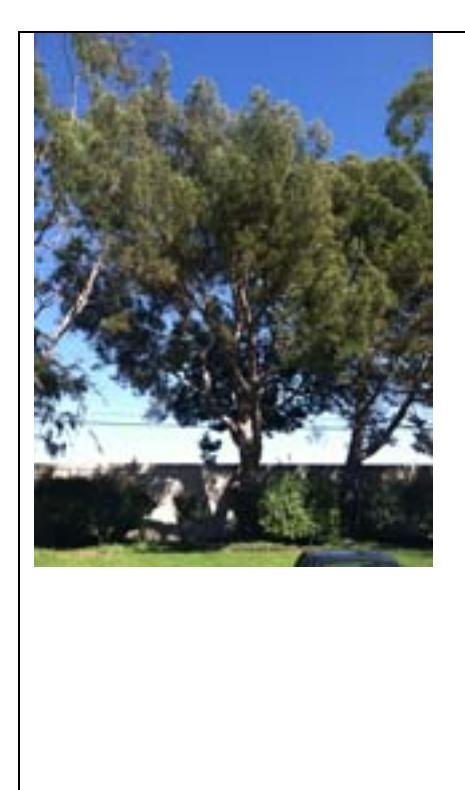
Site 133 Pinus halepensis – Aleppo Pine

This pine tree has a prominent co-dominant stem structure. The angle of attachment is sufficiently large that it is not the weakest point in the tree. The trunk of this tree is located approximately 3 feet from the newly constructed wall. Due to the size of this tree, nearly 40% of the root system was compromised due to the installation of the adjacent wall.

Currently, the tree's canopy form is approximately balanced between the east and west. The trunk leaning out over the wall to the east counterbalances the trunk on the west side. If the eastern trunk were to be removed, the western trunk would likely become a falling hazard due to the absence of tensile buttress roots on the eastern side. If the tree is to be retained, both halves of the tree should be retained.

Maintenance: 3 hours with climber Next Service: winter Priority: medium
