TREE INVENTORY

Prepared for
FRIENDS OF ROCKHAVEN FOUNDATION

Prepared by
JAMES KOMEN – CLASS ONE ARBORICULTURE INC.
RCA #555, BCMA #WE-9909B
(818)495-5344
CLASSONEARBORICULTURE@GMAIL.COM
MAY 24, 2015

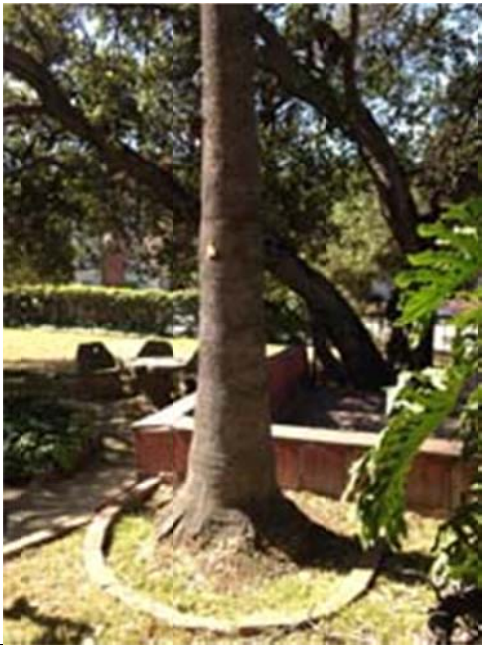
This palm tree nicely complements its neighbor to the east. In the recent past, it was climbed with spikes. These spike wounds are now exuding sap. Palm trees should never be climbed with spikes because they are unable to heal from those wounds.

Aside from the occasional removal of dead fronds, this tree needs relatively little maintenance. It may be difficult to access the upper canopy, but it might be possible to climb the adjacent oak tree and to prune out the dead fronds using a pole saw.

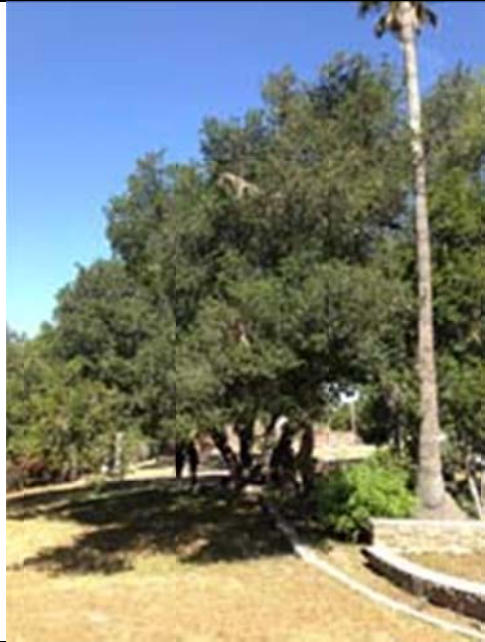
Tree #11

This oak has developed a prevailing lean to the east out from under the canopy of the dominant one to the west. This prevailing lean is not a problem. The canopy of the tree is full and dense. Because this tree was planted close to a garden wall, it will eventually cause the wall to crack. In this case, I recommend preserving the tree and fixing the wall as necessary.

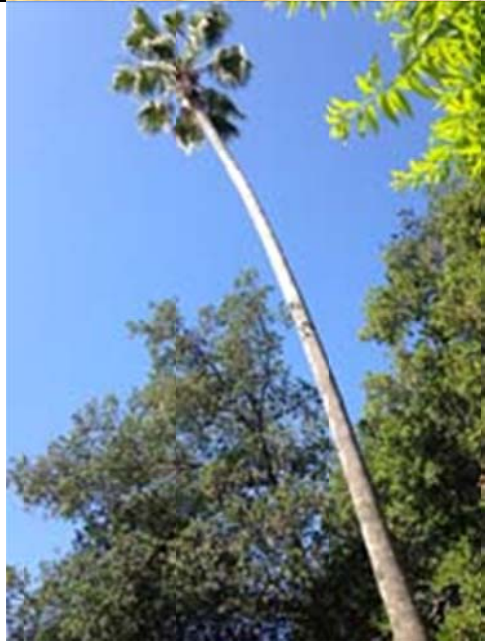
Tree #12

This palm nicely complements its partner to the west. It will periodically need to have its dead fronds removed before they self-prune. Other than the removal of dead fronds, this tree does not need much maintenance at all.

Care should be taken to avoid climbing this tree with spikes. Rather, an aerial lift or a boom trunk should be used to elevate a worker to a sufficient height to reach the fronds with a pole saw.

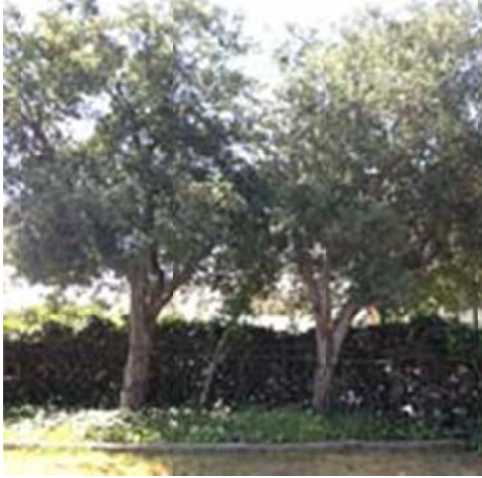
Trees #14-15

The two mature Oaks in this copse of trees have great form and good health. They both have significant growth cracks, indicating vigor. They have well-balanced canopies and add to the landscape value. Both of these two mature trees will need to be pruned for sidewalk clearance delicately and proactively before another entity takes action.

Tree 15 has a smaller branch originating from between two major scaffold branches approximately 6 feet up the trunk. The smaller branch should be removed to avoid creating a defect in the more desirable structures.

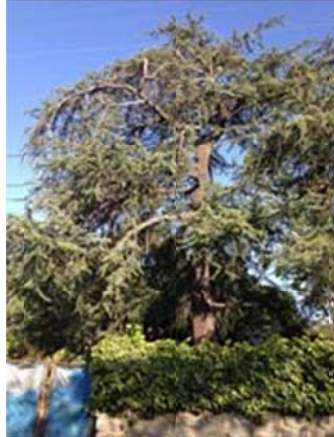
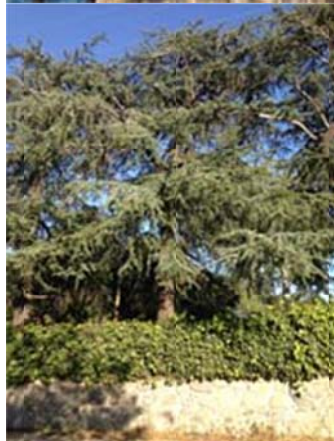
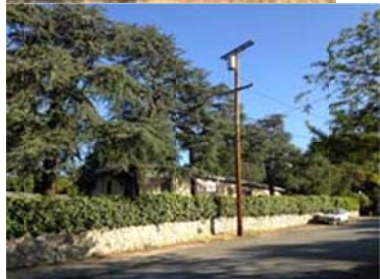
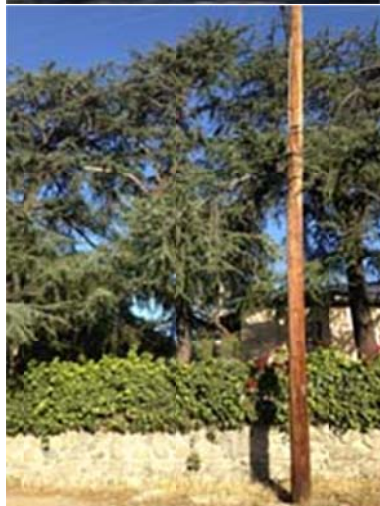
Tree #20 and 22-25
Cedrus deodara – Deodar Cedar

These trees are long-lived and in good health. There are a few recommendations for care:

These trees have been pruned for power line clearance. In the past, the line clearance pruning has left stumps headed towards the power lines. Because the Deodar Cedar is an excurrent species, it does not handle tipping cuts very well. These remaining stumps should be cut back to their parent stems and allowed to heal. If they are not cut back to the parent stems, then the trees will have to wait until they decay and fall off before they can roll a healing callous over the wound sites.

For future management of these cedars, it would be better to proactively manage the power line clearance rather than waiting for the power company to use more aggressive methods.

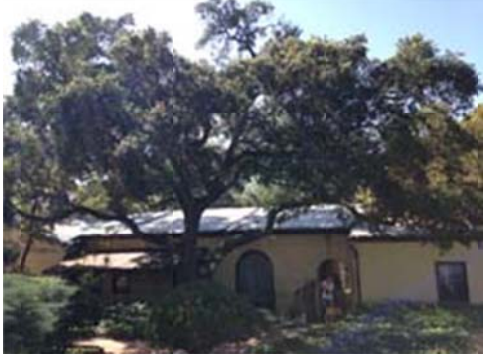
<p>Tree #33 <i>Quercus agrifolia</i> – Coast Live Oak</p> <p>This Coast Live Oak has limited root space between the building and the raised planter to the north. The roots are beginning to crack the patio. In the near future, the eastern trunk will also press up against the awning. Care should be taken to avoid damaging the trunk or the roots when repairing the infrastructure.</p> <p>There is a small load of deadwood in the canopy. This deadwood should be removed before it falls on the roof. The tree should also be pruned at least 5 feet away from the roof per City of Glendale fire code regulations.</p>

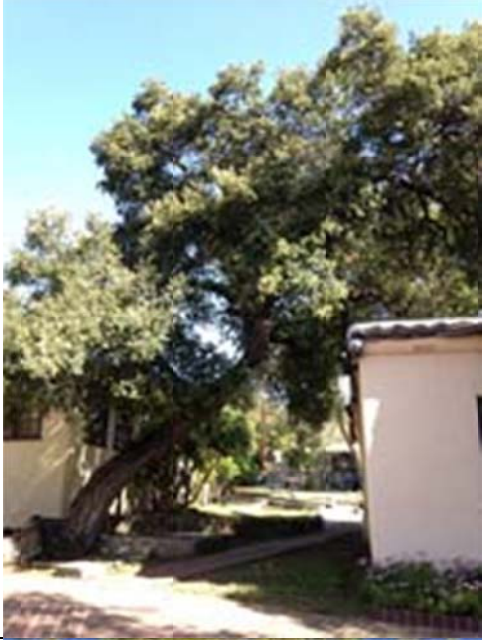
Tree #48

This Coast Live Oak creates immense value for this courtyard. The canopy cover between the two buildings is complete and the foliage is attractive and healthy. There is some deadwood that should be removed from the canopy before it self-prunes.

This tree was planted a little too close to the adjacent building. As a result, the root system is beginning to heave up the planter and patio. Given enough time, the tree may end up damaging the foundation of the adjacent building. A decision should be made whether to retain the tree and regularly repair the infrastructure or to remove the tree to preserve the infrastructure.

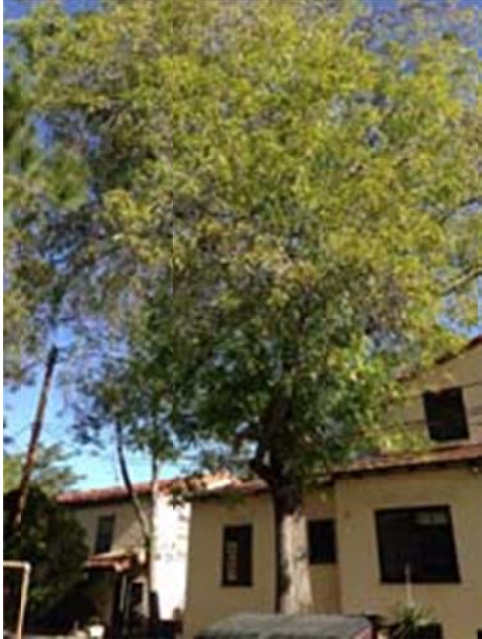
Tree #51

This ash tree appears to be in good health. There's some dead wood that can be removed in the early fall. The root system of this tree is cracking the tree's planter. If the planter is repaired, care should be taken not to sever roots. Severing roots this close to the tree could be detrimental to its health and safety.

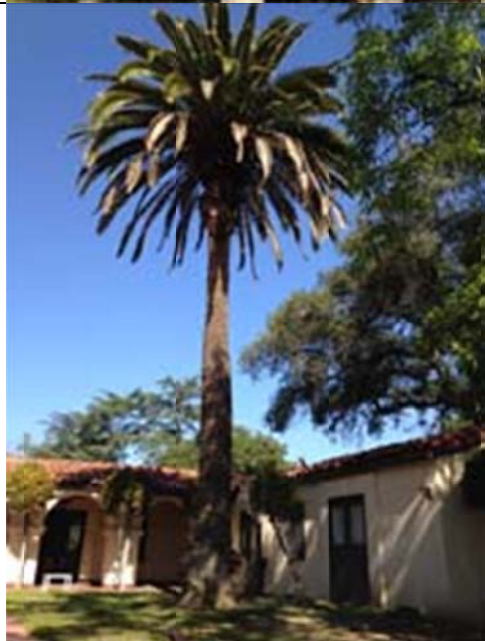
Tree #58

This is a good choice of species for the location. The canopy of this palm neatly covers the courtyard. Care should be taken to remove dead fronds and old fruiting structures periodically before they self-prune.

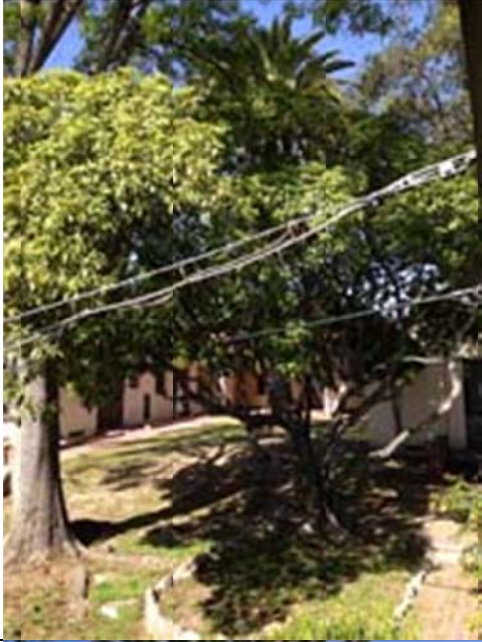
Tree #59

This tree is an excellent understory pairing with the adjacent ash tree. The foliage is healthy. Most of the interior shoots have been removed in the past. This is not ideal for the structure of the tree because it makes the branch unions carry more of the force of the wind. The tree should recover; it just needs to grow a few more feet over the next several years. Interior live branches should be retained where possible. The only pruning that needs to be done to this tree is the removal of deadwood, and the pruning for sidewalk and line clearance.

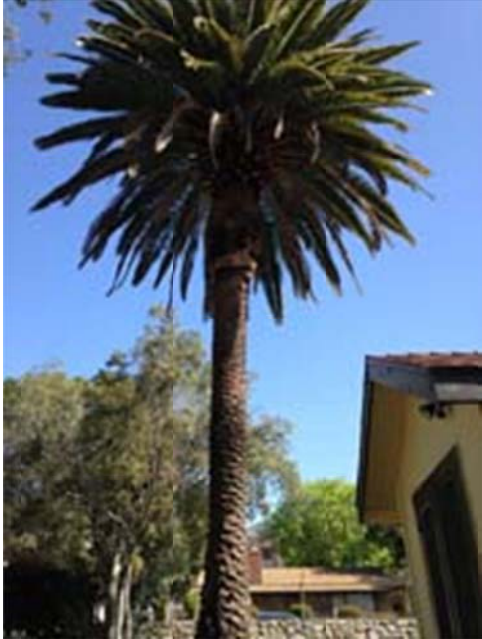
Tree #61

This palm tree has a stately appearance and is well chosen for the site. The dead fronds should be removed periodically before they self-prune. Care should be taken to sterilize pruning implements before pruning this tree to avoid transmission of the Fusarium fungus.

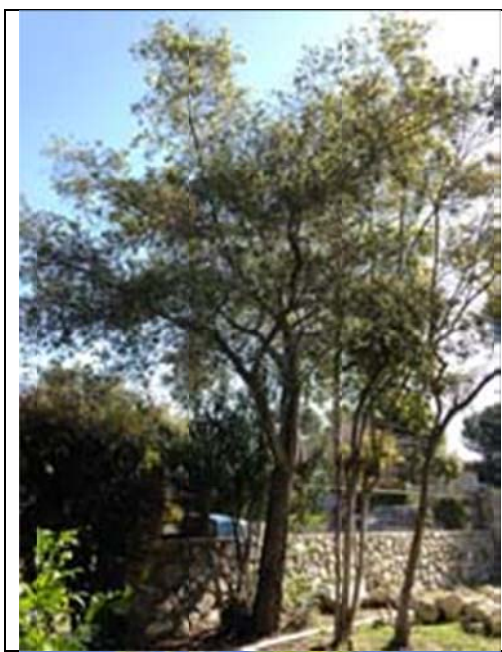
<p>Tree #61.1 <i>Quercus agrifolia</i> – Coast Live Oak</p> <p>This Coast Live Oak volunteer is a healthy specimen on site. However, it is growing very close to the back wall, and the back wall may eventually crack due to the growth of this tree. Preservation of this tree will require the eventual repair of the adjacent wall. It will need to be pruned every few years for sidewalk clearance.</p>

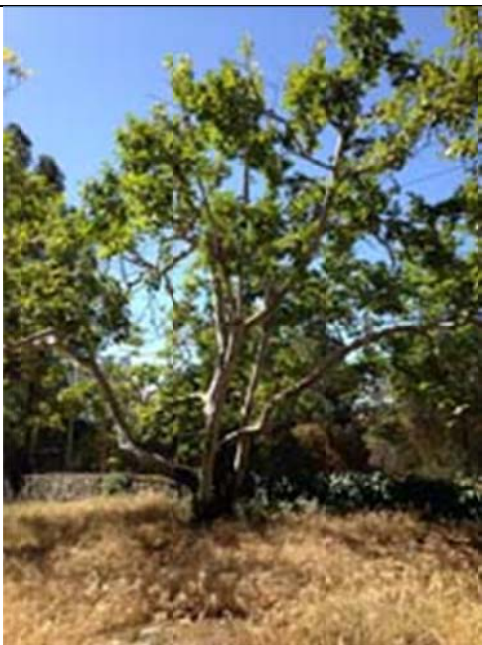
Tree #69

This multi trunk specimen is an attractive landscape feature. There is a buildup of deadwood in the canopy that should be removed. This tree should also be pruned for clearance with the adjacent power lines.

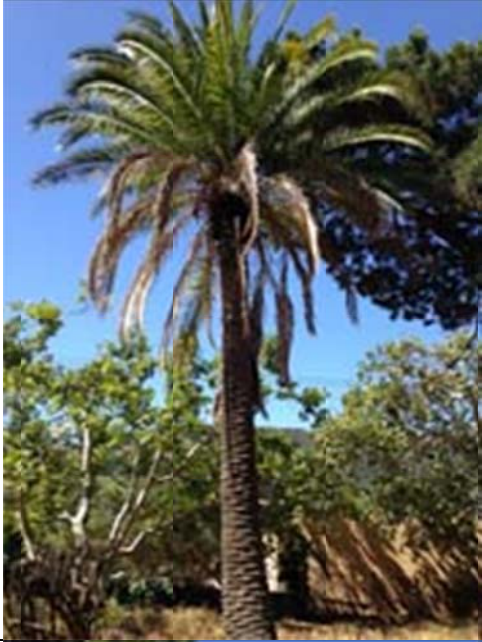
Tree #70

This Phoenix palm is growing well on site. There are some dead fronds that should be manicured out of the tree before they self-prune. No other action needs to be taken at this time.

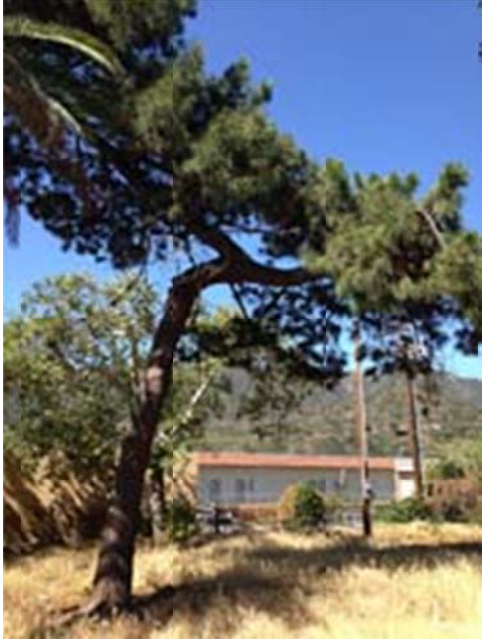
Tree #71

This stone pine lost one of its trunks many years ago. The tear-out wound still remains about 20 feet up the main trunk. The remaining trunk has grown laterally to the west, and one of its branches has taken over as the central vertical leader. Although this form is not ideal structurally, the tree can be retained in the landscape for now. There are some large dead branches that should be pruned out soon before they self-prune.

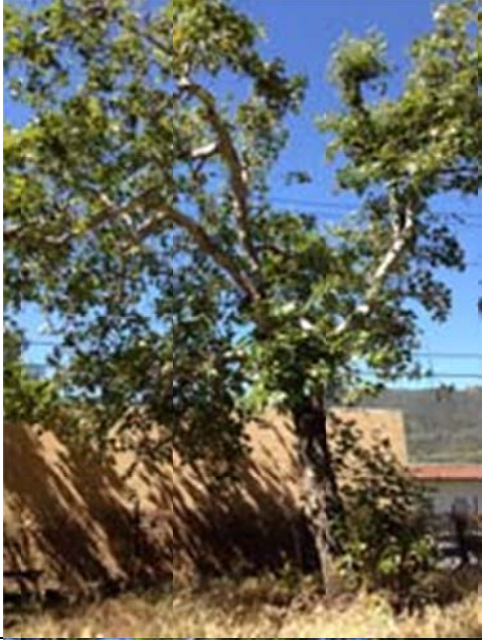
Tree #72

This is a healthy specimen of Sycamore that is doing well on site. The root crown shoots should be retained. There is deadwood in the canopy that should be removed. This tree will need to be pruned for clearance with the adjacent building and power lines.

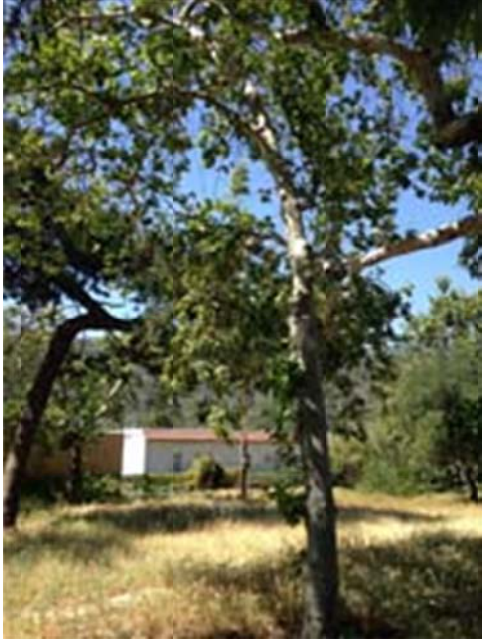
Tree #73

This younger Sycamore has subordinated to its neighbor. The prevailing lean that it has developed is not a problem. As much as possible, the shoots on the trunk should be allowed to remain so they can increase the trunk thickness and make the tree less susceptible to wind loads. Deadwood should be removed from the tree.

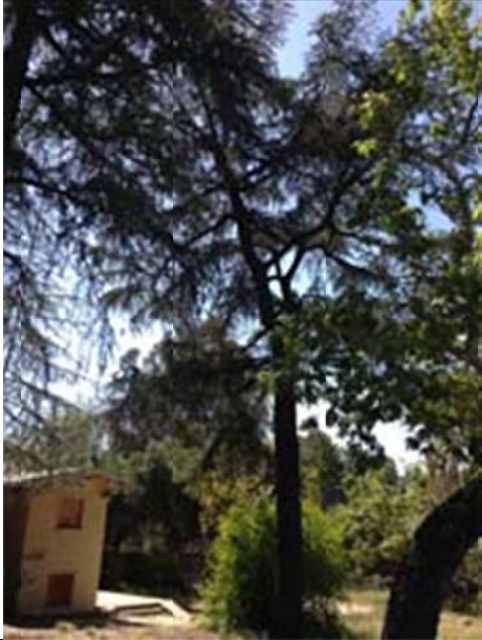
Tree #73.3

This is an excellent species of tree and has high value in the landscape. Very little should be done at this time. The angle of attachment between the two large trunks at about 25 feet up is sufficiently large that it is not a tear out hazard.

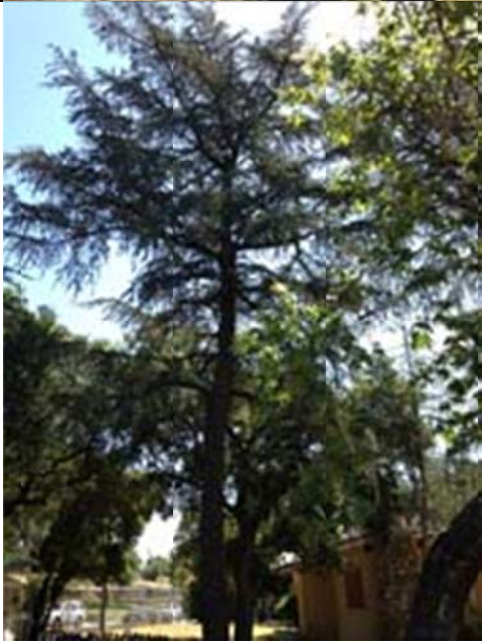
Tree #73.5

This Deodar cedar is a prime landscape asset. It is a low maintenance species and a high-value specimen. It is well placed in the landscape and has excellent form and vigor. Very little should be done to this tree at this time.

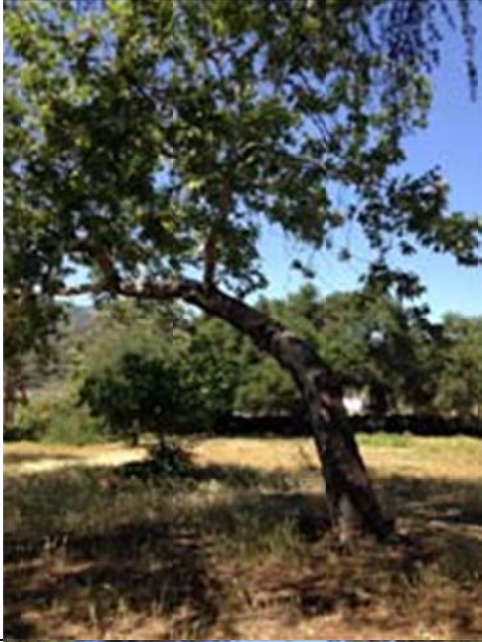
Tree #74

The Sycamore is in excellent health, but it has a very severe prevailing lean to the south. Currently, there is no target beneath it, so no action needs to be taken. However, if the area were to receive more foot traffic, it may be worth considering removing the parts of the trunk that are in heaviest cantilever. There is also some deadwood that should be removed from this tree.

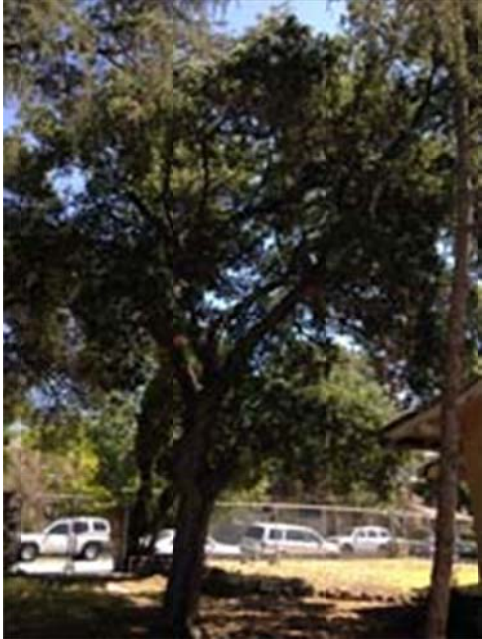
Tree #75

This mature oak has an ideal form and good health. The foliage is dense and full. The branching structure is excellent. This tree will need to be pruned for roof clearance with the adjacent building. There is also some minor deadwood that can be removed.

On the southern part of the trunk about 7 feet up, there is a decaying cavity from an old pruning wound. The wound is healing over, but decay has already begun to set in, so the callous will be closing over a pocket of decay. The extent of decay appears to be manageable enough that the tree may eventually heal over it. However, this cavity should be monitored as the tree completes its final stages of wound closure.

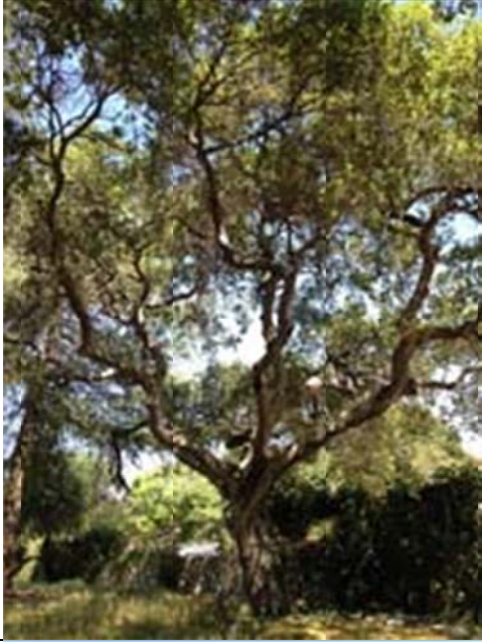
Tree #77

This mature oak is a fine landscape specimen. It has good form and good health. There is a buildup of deadwood that should be removed before it self-prunes.

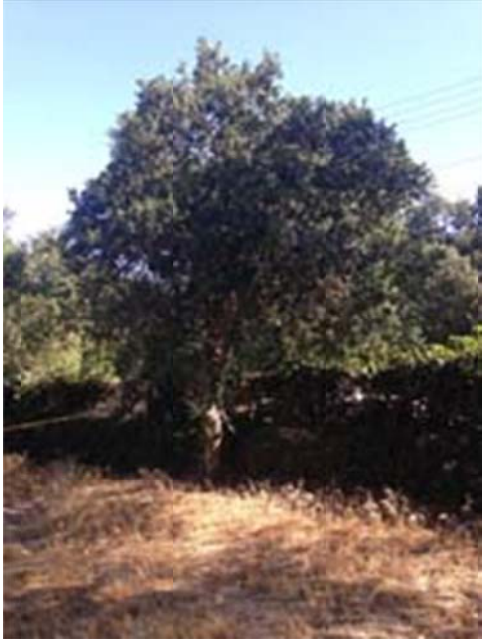
Tree #77.3

This oak tree is growing very vigorously on site. It appears to have been a volunteer because of its close proximity to the stone wall to the north. There are many growth cracks along the trunk, indicating that the tree is rapidly expanding. As it grows, this tree will come into conflict with the adjacent wall. A decision will need to be made whether to retain this tree and repair the wall eventually or to preserve the wall and remove the tree.

There is English Ivy on the adjacent wall that is beginning to colonize the canopy of this oak tree. The ivy should be removed before it becomes a nuisance and shades out the more desirable oak foliage.

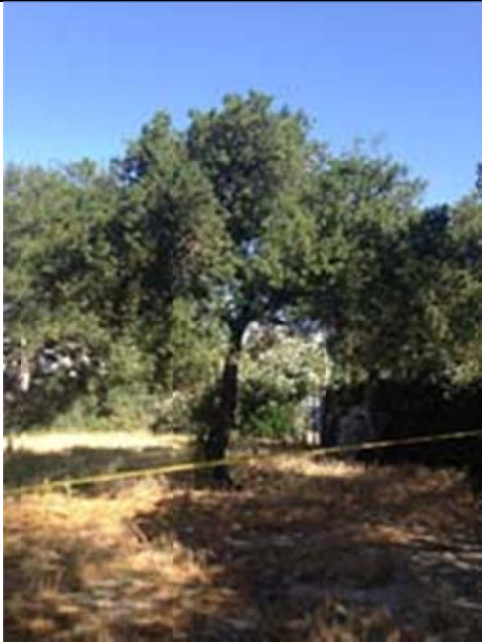
<p>Tree #77.5 <i>Quercus agrifolia</i> – Coast Live Oak</p> <p>This young oak tree has good form and healthy foliage. There is an old metal spigot that has become impounded in the root crown. No attempt should be made to remove the spigot now because that would cause further damage to the tree. Rather, the spigot should be cut flush to the trunk without damaging the bark.</p> <p>Along the southern side of the trunk, there are many adventitious shoots that have sprouted. These are likely a response to the increased solar exposure from the south due to the removal of another tree that had formerly shaded this tree's trunk. In response to the increase in sunlight, the tree sent out new adventitious shoots to shade the bark from sunburn. These shoots should be retained on the tree for as long as possible.</p>

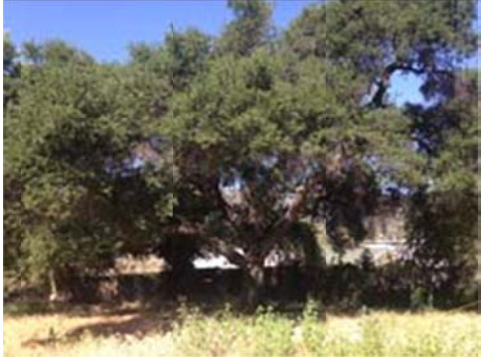
Tree #80

This majestic oak has a fantastic canopy spread and good structural form. However, there is one major problem with the tree. There are two very large sites of bark loss on the north and western sides of the root crown. This indicates that roots may have been damaged many years in the past, and bark along the root crown had died back.

The exposed heartwood is solid 2 to 3 feet above ground level. However the wood closer to the ground is hollow and decayed. There is frass around the base of the tree, which is evidence of wood boring insects. The structural integrity of the tree does not appear to be compromised to the point where the tree is a hazard in the landscape. However, these wound sites should be monitored regularly. If the tree is able to deposit new tissue faster than decay organisms can advance, then the tree may survive the injury and continue to live in the landscape. However, if decay advances too quickly, then the tree will become structurally deficient and may need to be evaluated for hazard potential.

There is a minor load of deadwood in the tree. The deadwood is from the natural process of shade out dieback. The canopy of this oak tree is so healthy that it is shading out the interior foliage from light.

Some English Ivy is beginning to colonize the trunk. It should be pulled down before it becomes a nuisance in the tree.

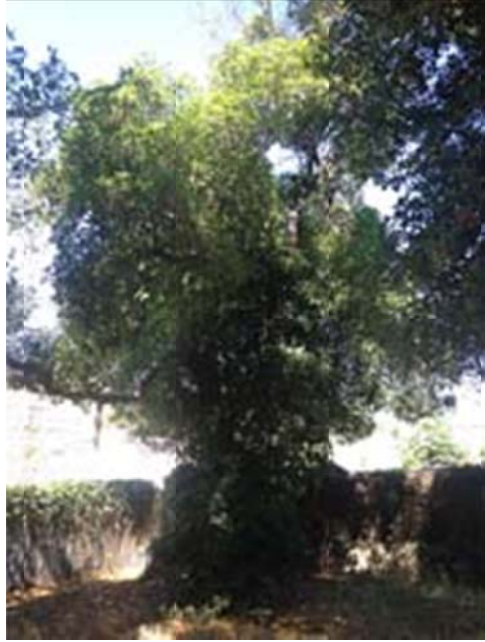
Tree #82

The old scars from the sunburn injury still remain on the trunk. Bark is peeling off the old sunburn wound, leaving the tree open to wood boring insects and decay organisms. This wound site should be monitored. There are some dead branches in the tree that should be removed.

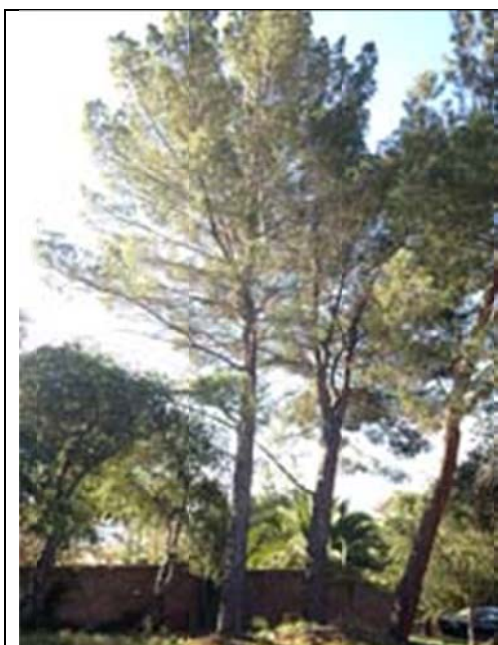
Tree #90
Pinus halepensis – Aleppo Pine

Of the three pine trees in the grove, this one is the least vigorous. There is a buildup of deadwood in the lower part of the southern canopy. It would be a good idea to prune out this deadwood before it self-prunes. The cause of this deadwood is likely the limited solar exposure this tree receives being located to the north of the two more dominant pines. The remainder of the canopy that receives sufficient light appears healthy and vigorous. Aside from removing deadwood, no action is needed at this time.

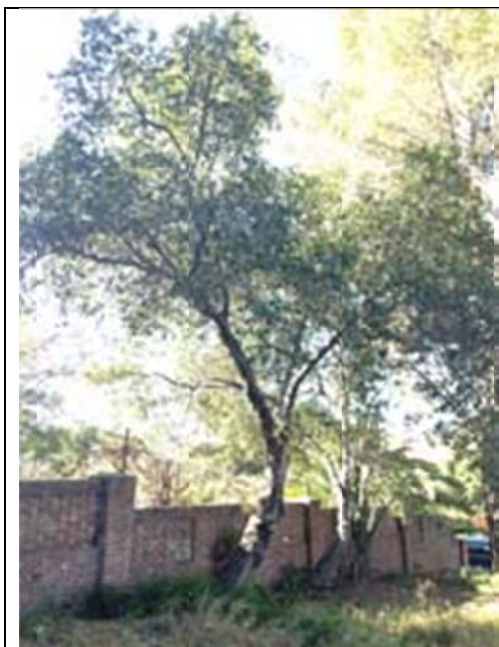
Tree #92

This tree has great form and a vigorous canopy. There are a few old pruning wounds on the trunk that are healing over nicely. Because it is located so close to a historic brick wall, it will eventually grow in size and cause the wall to crack. A decision should be made whether the wall should take priority over the tree or vice versa. If the tree is retained, the wall will need to be periodically repaired. If the wall is preserved, the tree will need to be removed to prevent further damage.

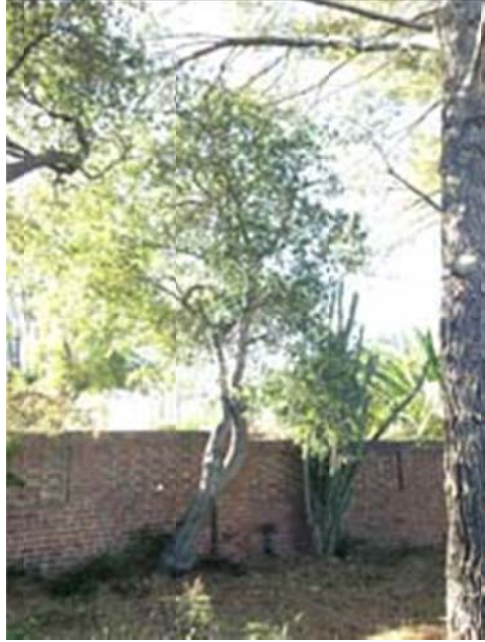
Tree #92.5

This oak has one major defect in form: co-dominant trunks. Two trunks twist around each other and have a point of contact approximately 6 feet off the ground. As they grow and expand in girth, these two trunks will press up against each other at this point of contact, constricting the flow of water and nutrients. Also, this point of contact will turn into an entry point for decay organisms.

At the union of the stems, towards the base of the tree, the angle of attachment is very narrow. There is no room for a branch bark ridge to develop, and the bark is just being pressed together. Because of this included bark, the size of the attachment union will not grow proportionately to the trunks. Eventually, the union will be insufficient to hold the tree together, and one of the trunks will tear out and fail.

If this tree is to be retained on site, I recommend removing the lower of the two trunks, originating on the western side of the main stem. This would remove the undesirable point of contact and the included bark. There is still plenty of foliage on the remaining trunk to support the tree's vigor.

However, a broader consideration should be given to this tree as well. Because it is located so close to this historic brick wall, it will eventually grow in size and cause the wall to crack. A decision should be made whether the wall should take priority over the tree or vice versa. No action should be taken on this tree until a decision is made.

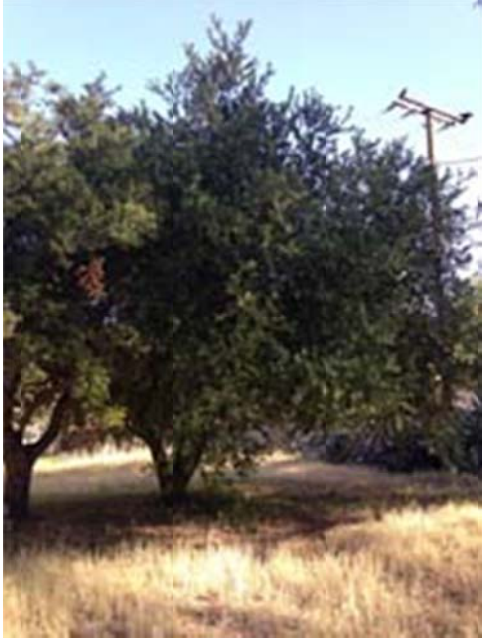
Trees #93-95

All three trees have growth cracks, indicating vigor. No pruning is necessary at this time.

No action should be taken to correct for this. One of the natural adaptations of oak trees is the ability to grow into a new space and adapt to changing light conditions. Each of these trees will easily fill the available space on the outer perimeter of the grove. Furthermore, by growing together, these trees protect each other from wind loads. Rather than bearing the force of the wind load, each tree shares a portion of it, reducing the likelihood of failure in wind.

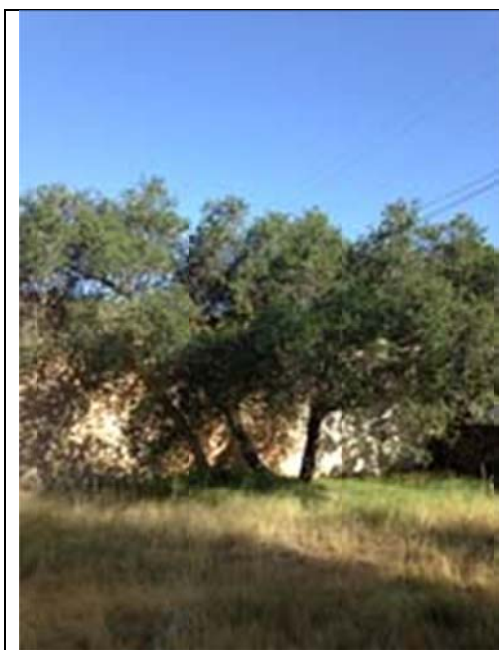
<p>Tree #96 <i>Quercus agrifolia</i> – Coast Live Oak</p> <p>Fill soil has accumulated around the base of this tree and has buried the root crown flair. This could pose a problem for the tree by encouraging decay organisms to attack the root crown. Coast Live Oak is particularly susceptible to such an attack. If possible, the fill soil should be gently removed to expose the root crown flair to air. Doing this will reduce the likelihood of fungal infections such as Phytophthora and Armillaria.</p> <p>The canopy of this tree is healthy and vigorous. There are many branches that are in contact with the adjacent building to the west. Care should be taken to proactively prune for roof clearance before the adjacent building's owner takes action.</p>

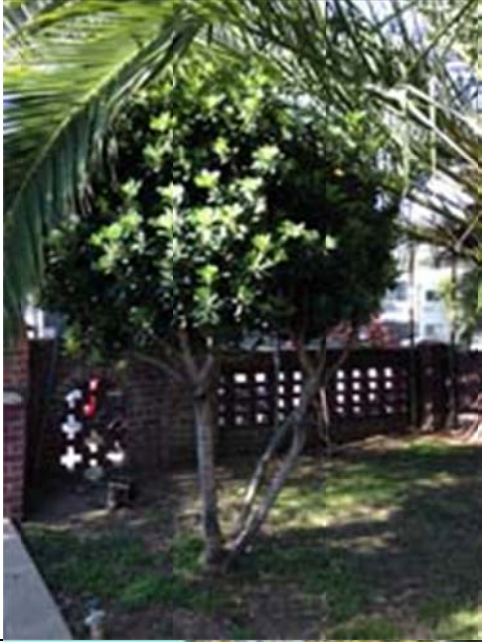
Tree C
Pittosporum tobira – Victorian Box

This young mock orange tree will make a nice understory pairing with its neighboring palm tree. In the past, the low branches have been removed from the small tree. This practice should be discontinued. The best method of training this tree is selective shoot removal and shearing of first year growth.

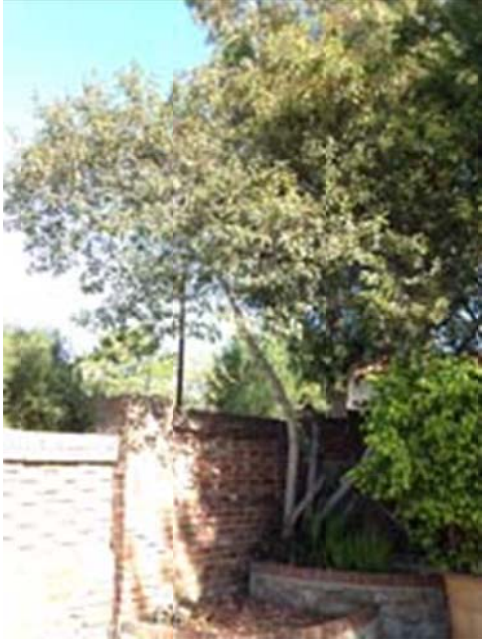
Tree D
Heteromeles arbutifolia – Toyon

This toyon is growing a little too close to this brick wall, and its trunks and roots are now pressing against it, causing damage. A decision should be made whether the tree should be retained and the wall restored around it or the tree should be removed and replaced with a new specimen planted further from the wall.

In the past, this tree's lower limbs have been removed. The remaining foliage is at the tips of each of the multiple trunks. In the future, pruning should not remove any more low branches unless they conflict with head height clearance. The more lateral branches the tree has, the better its ability to dissipate wind loads.

There are several old dead trunks that should be removed.

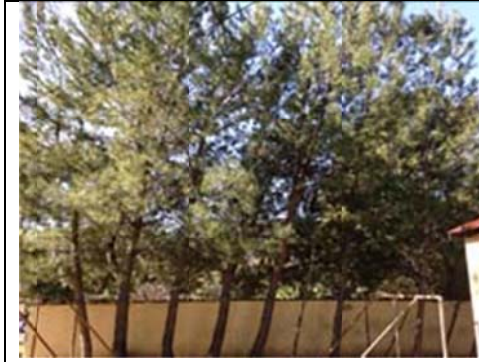
Tree E
Pinus radiata – Monterey Pine

This hedge of pine trees is aging beyond its size limitations. When this hedge was planted, the density of planting was acceptable. However, now that the trees are maturing, there is not enough crown space for each individual tree. I recommend selectively thinning out the weaker trees to allow more space for the stronger ones. The landscape managers should be aware that eventually the roots of these trees may crack the adjacent wall.

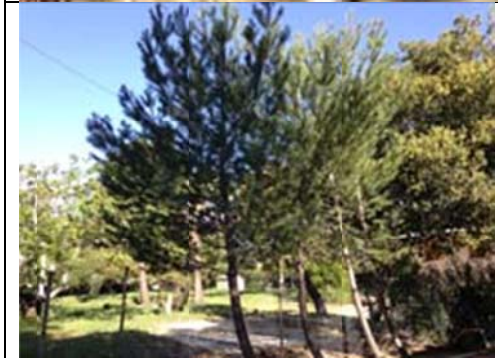
Tree G
Pinus radiata – Monterey Pine

This row of pines is healthy and attractive. As it grows, two of the trees will need to be culled out to allow space for the others. The northernmost tree is the first candidate, and then the Middle tree of the remaining three. By thinning the grove, the remaining trees will have more space to grow and will develop more stable canopies for the long-term.

There is a surface irrigation pipe running along the ground immediately adjacent to the trunks. Eventually, the growth of these trees will press against this irrigation line and cause it to crack. I recommend considering rerouting the line to give more space for the trunks of these trees.

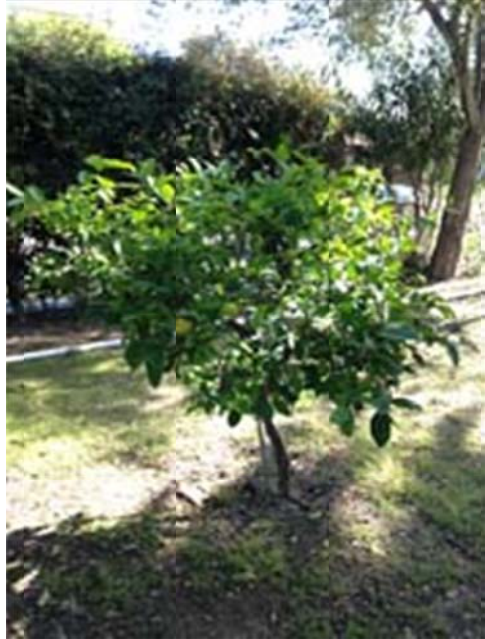
Tree L

This lemon tree is thriving in the mottled shade of its neighboring trees. Shoot elongation is good, and the leaves appear healthy. The metal stake in the ground should be removed if it can be easily pulled out of the ground. Otherwise, it should be sawed off at ground level to avoid damaging the tree's root system during removal.

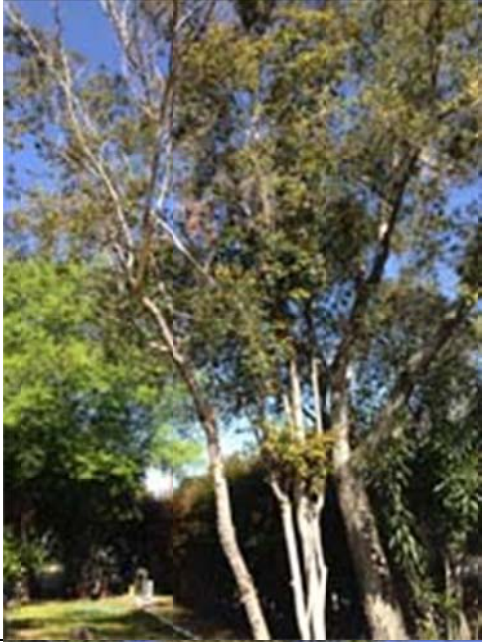
Tree N
Syzygium australe – Brush Cherry

This brush Cherry is competing with the neighboring oak. In its current form, it will not be useful to the landscape and will only cause harm to the adjacent oak. Therefore, I recommend removing this tree. Do not grind the stump because it will damage the roots of the oak. Rather, cut this tree to ground level. The neighboring brush cherry is dead and it should be removed as well.

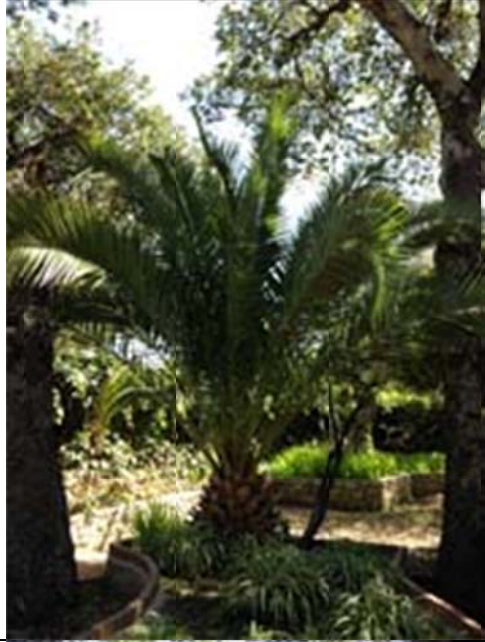
Tree T

This was not the ideal site for this palm tree. Eventually, it will grow to be in conflict with the oak tree above it. For now, it can be retained as an understory tree. However, in about 10 years, a decision will have to be made whether to retain this palm tree and prune space for it or to remove it.

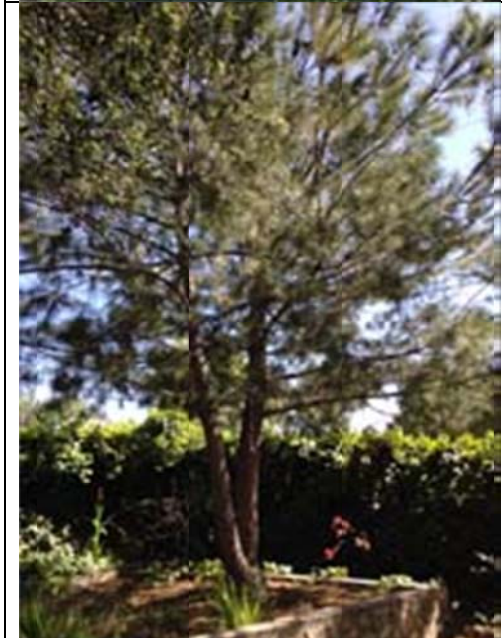
<p>Tree X <i>Pinus radiata</i> – Monterey Pine</p> <p>This young Aleppo Pine will quickly outgrow its available root space. The planter box will crack from the force of the expanding roots. A decision should be made whether to preserve this tree or the planter. The tree is in good health and should have some gentle structural pruning to train it into a long-term form if the tree will be retained.</p> <p>The tree has a co-dominant trunk form, but the angle of attachment of the two trunks is sufficiently large that it does not pose a problem at this time.</p>

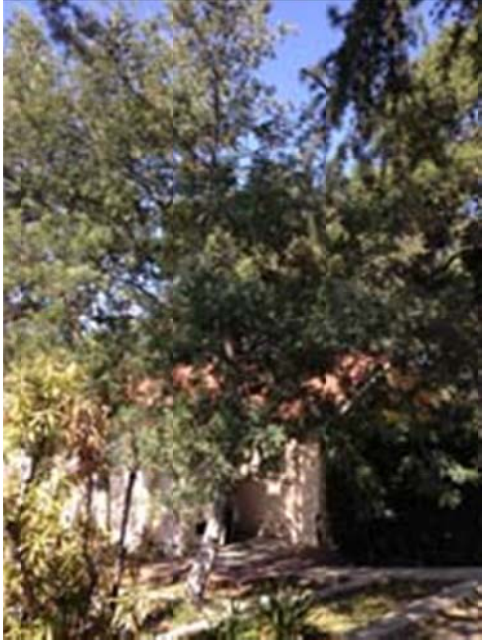
Trees AI and AJ
Acacia baileyana – Bailey's Acacia

These acacia trees either volunteered here or were planted by mistake. The species of Acacia tends to be very weedy and difficult to remove. The roots develop suckers that grow from the ground as separate tree trunks. These trees are also fast growing and have weak wood. The tree to the north has a prevailing lean to the north and will likely fail within 10 to 15 years. Furthermore, the tree to the north is growing towards the power lines and will need to regularly be pruned back. The species of tree can grow 3 or more feet in a single year.

Both trees are exuding sap at the root crown, indicating there is some sort of internal injury, either biotic or abiotic. I don't recommend preserving these trees on site. They do not carry a historical significance to Rockhaven. Rather, they are a liability to the landscape.

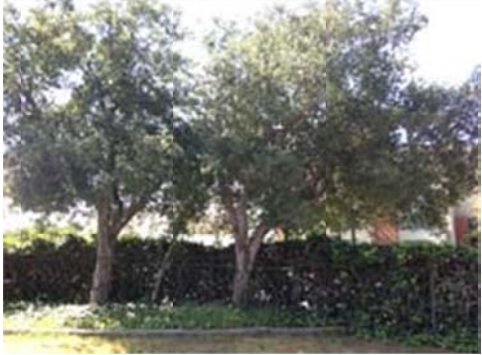
<p>Tree AL <i>Quercus agrifolia</i> – Coast Live Oak</p> <p>This tree appears to be a volunteer oak that has subordinated to the mature ones. It has developed a strong prevailing lean to the south out from under the canopies of the two mature trees. It does not have any significant foliage on the north side, and even if the two mature trees were to die and this tree were to become a succession tree, it would still have poor form and would likely fail in the wind if it were a standalone tree. Rather, this tree should probably be removed now before it grows to compete with the canopies of the neighboring mature oaks.</p>
---	---

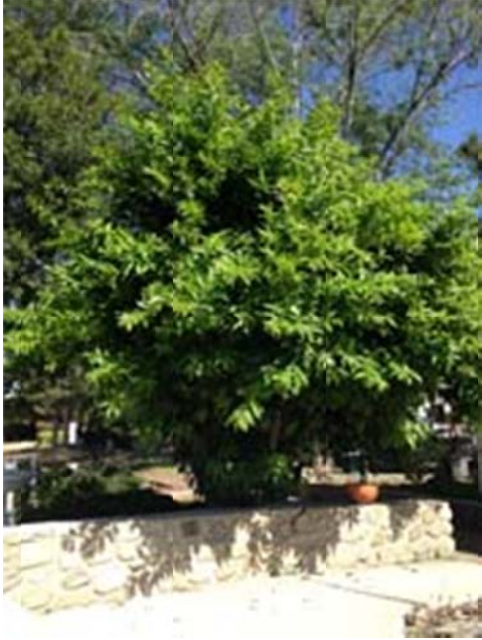
Tree AM

This bushy tree has been pruned back hard in the past periodically to reduce its size. In response, it produced many response shoots at each of the pruning wounds. Over time, these response shoots competed with each other for light and left the tree with an undesirable scaffold structure. The scaffold structure defects are not a severe problem because this tree would not pose a hazard if one of its trunks were to fail.

The trunk of this tree is pushing up against the patio wall. A decision should be made whether to preserve the tree and fix the wall or to preserve the wall and remove the tree. The English Ivy will need to regularly be pruned off of this tree to keep it from colonizing the canopy.

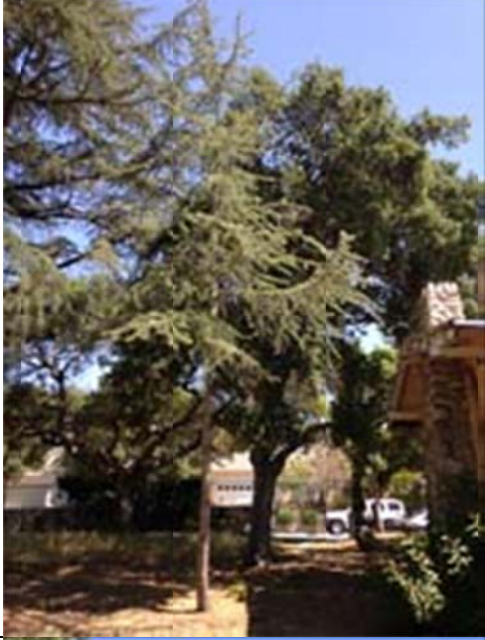
<p>Tree AN <i>Cedrus deodara</i> – Deodar Cedar</p> <p>This young deodar cedar is growing towards the south out from under the dominant oak to the north. This young tree will make a good succession tree for the landscape, and it should be preserved as possible. This will require very little maintenance in the near future.</p>

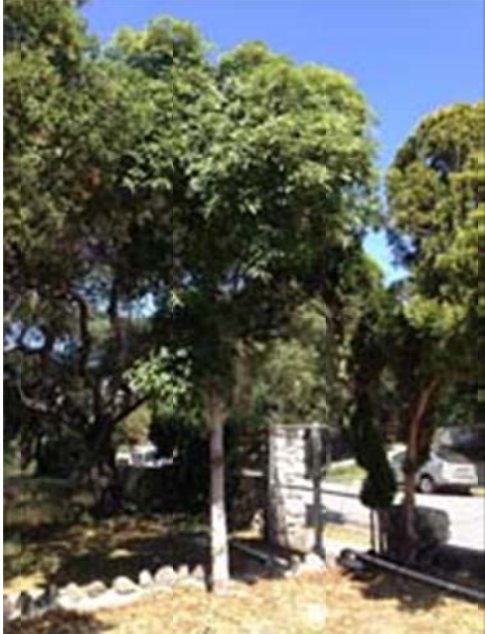
<p>Tree AO <i>Pittosporum undulatum</i> – Victorian Box</p> <p>This young <i>Pittosporum</i> is going to make an excellent understory tree companion to its neighboring oak. Not much should be done to this tree at this time. Eventually, its roots may displace the small garden wall adjacent to it. A decision should be made whether to retain the tree and periodically fix the wall or to preserve the wall and remove the tree.</p>

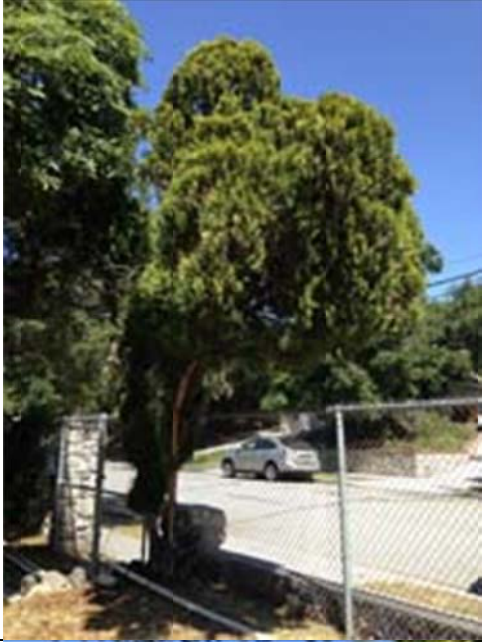
Tree AP

Juniperus chinensis 'torulosa' – Hollywood Juniper

This Juniper was likely originally planted as a small bush. After years of neglect, it has grown into a small tree. The installation of the back fence has necessitated the removal of several trunks. This disfigured the tree, leaving only two trunks. These trunks can remain for now, but this ill-placed and poorly cared-for tree is not worth much at this time.

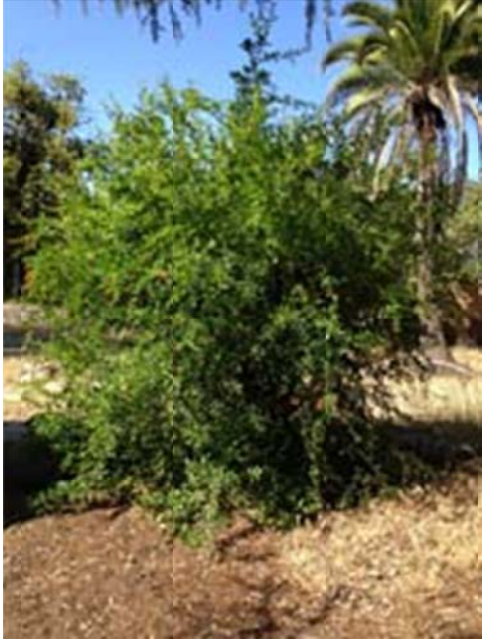
Tree AS

Punica granatum – Pomegranate

This pomegranate tree has healthy foliage. In the past, it was cut back to stumps at about 6 feet in height. The tree subsequently responded with secondary growth shoots emerging from the stump cuts. Although topping cuts are not recommended arboricultural practice, this tree appears to be handling them well. There is normal flowering and fruiting at the tips of the current year's growth.

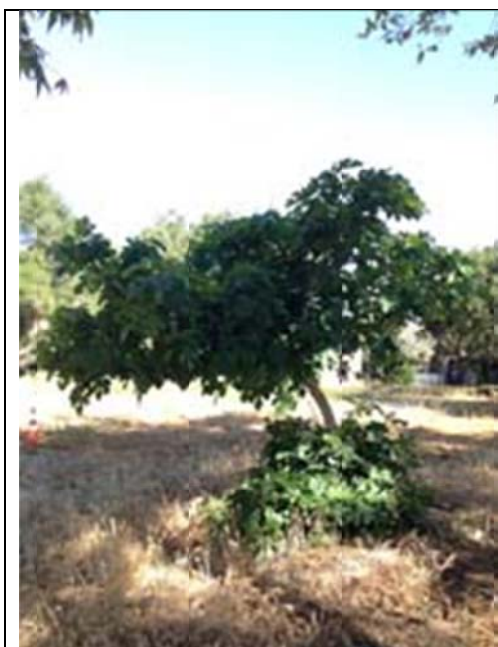
Tree AT
Ficus carica – Common Fig

This fig tree is thriving in the partial shade of the neighboring sycamore trees. There is a light fruit load in the canopy, and the foliage appears healthy.

There is a substantial wound site towards the base of the tree on the southern side where there was likely a second trunk that tore out some years ago. The tree is currently healing this wound site by rolling a cambium callous over it. There are many root crown shoots emerging from the base of the tree in response to this wound. These shoots should be retained because they will speed the deposition of the cambium tissue and help the tree heal this wound.

There is a possibility that the tree has already been compromised due to decay. However, since the tree is not very large and does not have a target, there is no reason to take action at this time.

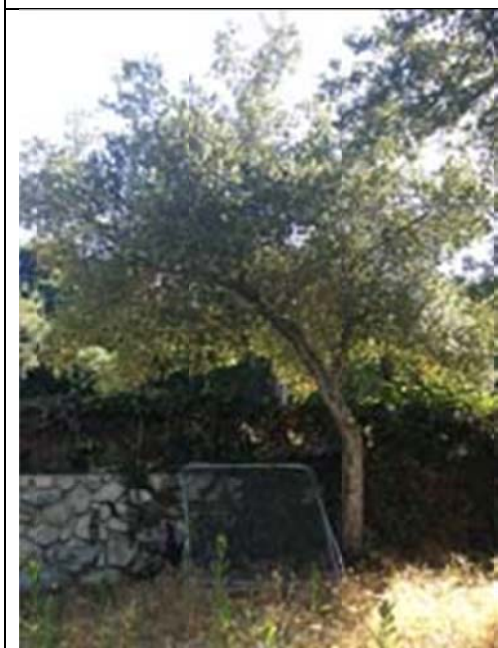
Tree AW
Quercus agrifolia – Coast Live Oak

This young oak looks as healthy as its neighbor to the east. There are many growth cracks up and down the trunk, indicating trunk expansion and tree vigor. The canopy appears healthy, and the structure is good.

The bigger problem with this tree is its eventual conflict with the adjacent wall to the north. As it expands, its roots will crack the adjacent wall. A decision should be made whether to retain the tree and periodically fix the wall or to preserve the wall and remove the tree.

The English Ivy growing along the wall to the north will tend to grow up the trunk of this tree. Regular maintenance should prune the ivy out of the canopy.

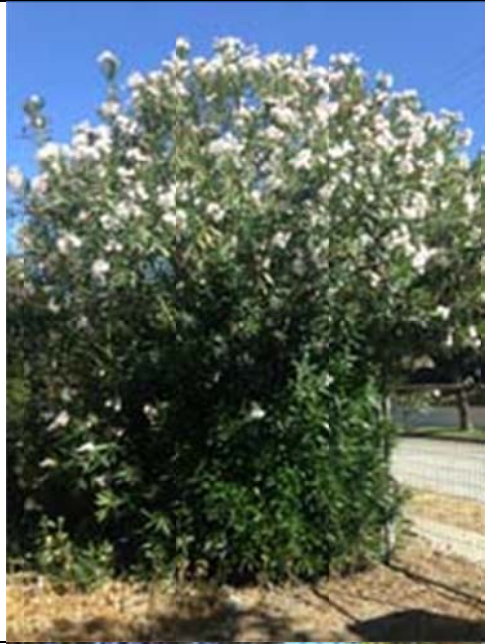
Tree AX

Oleander nerium – Oleander

The specimen is doing very well on site. The foliage and flowers look good. This is surprising because a local blight of verticillium wilt has wiped out many of the local oleander plants. This tree should be monitored for any future symptoms that may appear.

In the past, this Oleander was cut back to stumps at a height of about 9 feet. Subsequently, the plant resprouted with many new shoots. Although this practice is not recommended arboriculturally, the Oleander appears to have tolerated it.

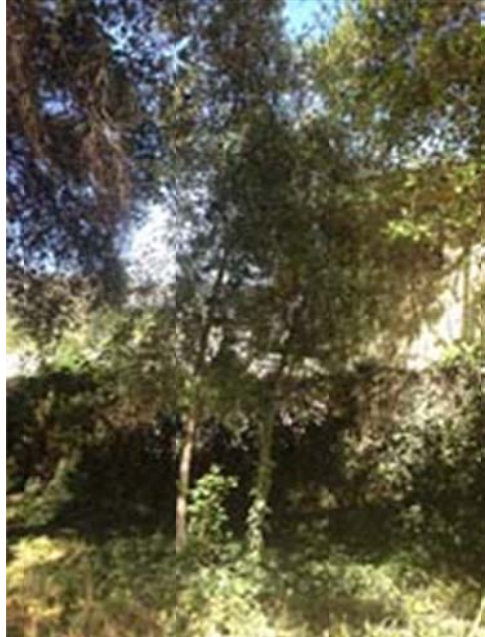
Tree AY

Olea europaea – Olive

This young olive tree is subordinating to the dominant neighboring oak to the south. It is attempting to grow out to the west from under the canopy. The foliage of this olive tree looks healthy, and no action needs to be taken at this time. Eventually, it will need to be pruned for clearance of the neighboring property's building. English Ivy is beginning to colonize the base of this tree. Regular maintenance should remove the ivy out from this tree so that it does not shade out the desirable foliage. This tree will make a good succession plant for the mature oak to the south.
