TREE INVENTORY

Prepared for
FRIENDS OF ROCKHAVEN FOUNDATION

Prepared by
JAMES KOMEN – CLASS ONE ARBORICULTURE INC.
RCA #555, BCMA #WE-9909B
(818)495-5344
CLASSONEARBORICULTURE@GMAIL.COM
MAY 24, 2015

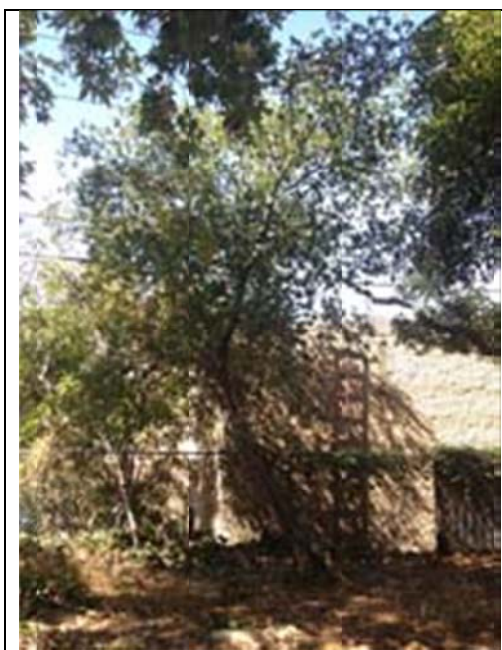
<p>Tree BA <i>Quercus agrifolia</i> – Coast Live Oak</p> <p>This young oak is doing well on site. There are growth cracks that indicate the tree is vigorously growing and expanding. This tree will need to be addressed for conflict with the power lines above it. The southern trunk is growing directly into the power lines, and several of the branches have become intertwined with the low telephone lines. This trunk should be removed, and the tree should be trained to the north, away from the power lines.</p>
